Project Title - Evaluation of CruzPro ATU120BT

File Ref.
TR-21-03

Evaluation of CruzPro ATU120BT Active Sonar Transducer for Manned Submersibles

May 5, 2021

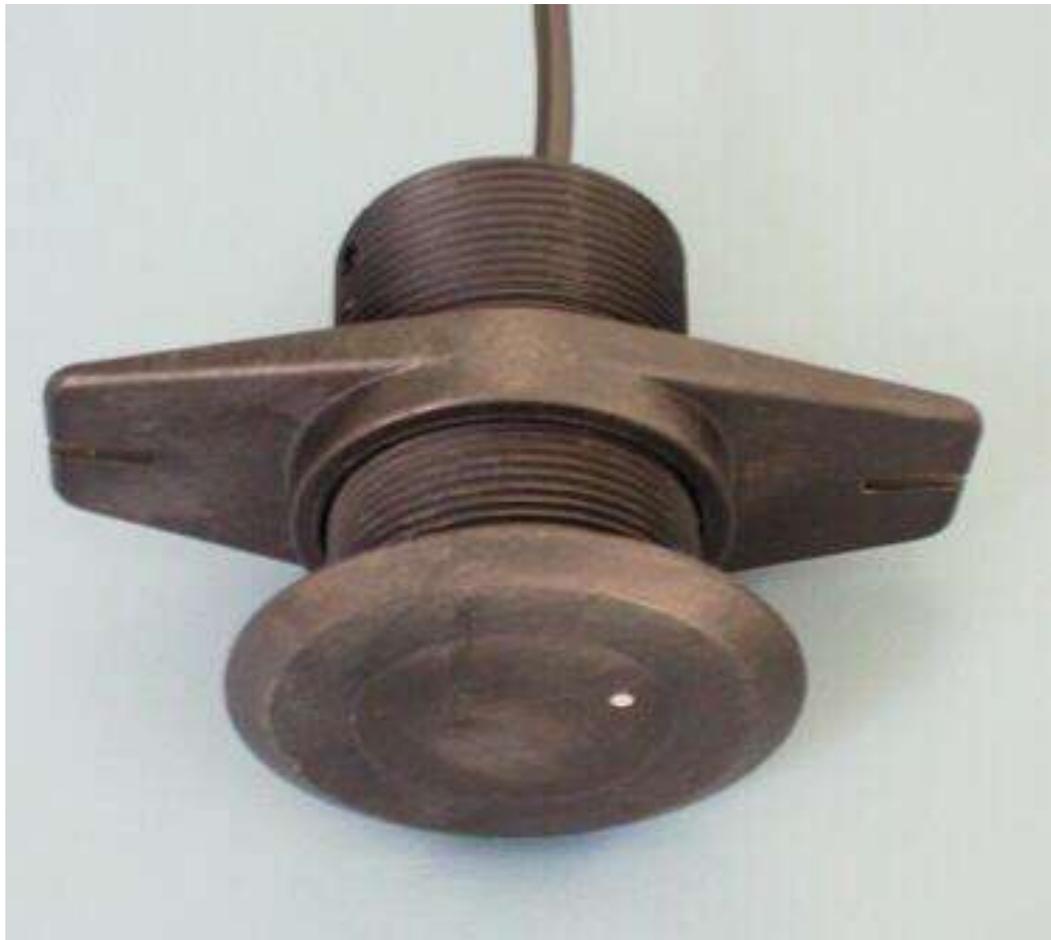
Figure 1 CruzPro ATU120BT Active Sonar Transducer

The goal of this project was to document the performance of the CruzPro model ATU120BT active sonar transducer shown in Figure 1. Specifically, the ability of the unit to continue to transmit NMEA 0183 sentences at a target depth of 1,000 fsw was to be determined. If the unit passed this test, then a stretch goal of 1,200 fsw was planned. Prior to the test a FEA analysis was conducted to determine the stress imposed on the transducer due to the hydrostatic pressure.

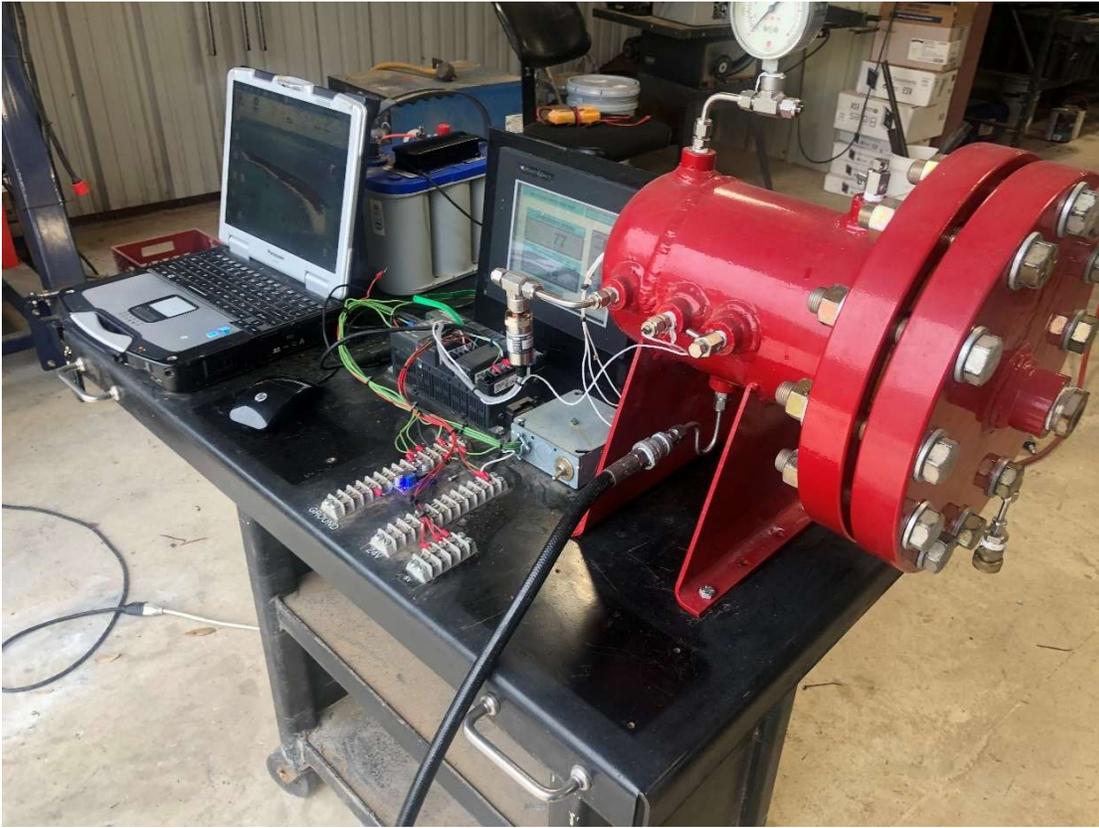
Figure 2 Test Chamber with transducer installed

To conduct the experiment, a test chamber was utilized shown in Figures 2 and 3. A positive displacement, triplex plunger pump was used to generate the pressure for the test with salt water as the media. The adjustable pressure relief valve for the pump was set at 500 psig which sets the maximum pressure the chamber achieved.

As seen in Figure 2, to setup the pressure test of the ABU120BT transducer, a 3,000 psig pressure transmitter was calibrated and wired into the Automation Direct 205 series PLC analog input card. A bourdon pressure gauge was also installed as a backup. The PLC hardware as well as the I/O for the test is shown in Appendix A. A positive displacement pump in the pressure washer was used to develop the pressure. An RTD was installed in the test chamber to measure the temperature. The ABU120BT was wired to a DB-9 connector that was plugged into the serial port of a laptop. Tera Term, an open-source, free, software implemented, terminal emulator (communications) program, was used to display the NMEA 0183 output sentences. Note that the RX wire normally included on RS-232 serial devices is not included on the ABU120BT. As such, there is no mechanism for uploading firmware changes to the ABU120BT transducer. The cold-water supply to the test-stand supplied pressure at approximately 76 psig. This corresponds to 171 fsw which is the minimum depth test conducted. For higher pressures, a bypass vernier valve

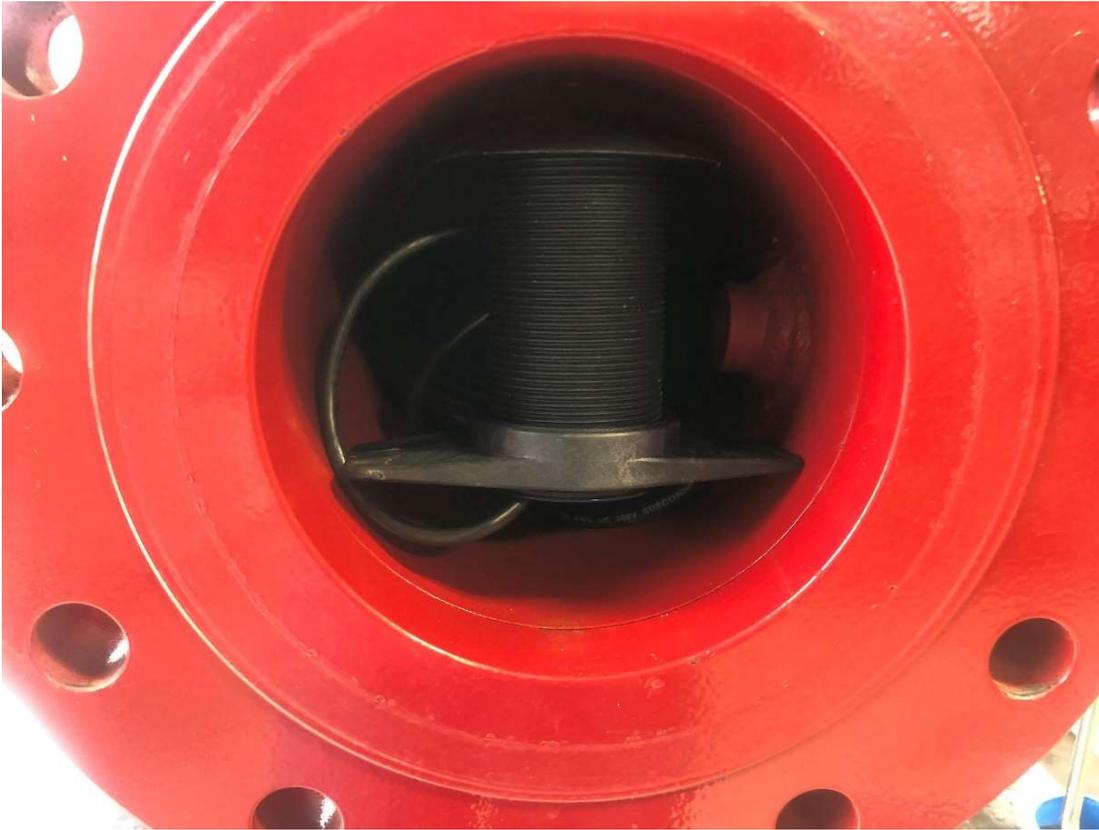
Figure 3 - Transducer orientation during test

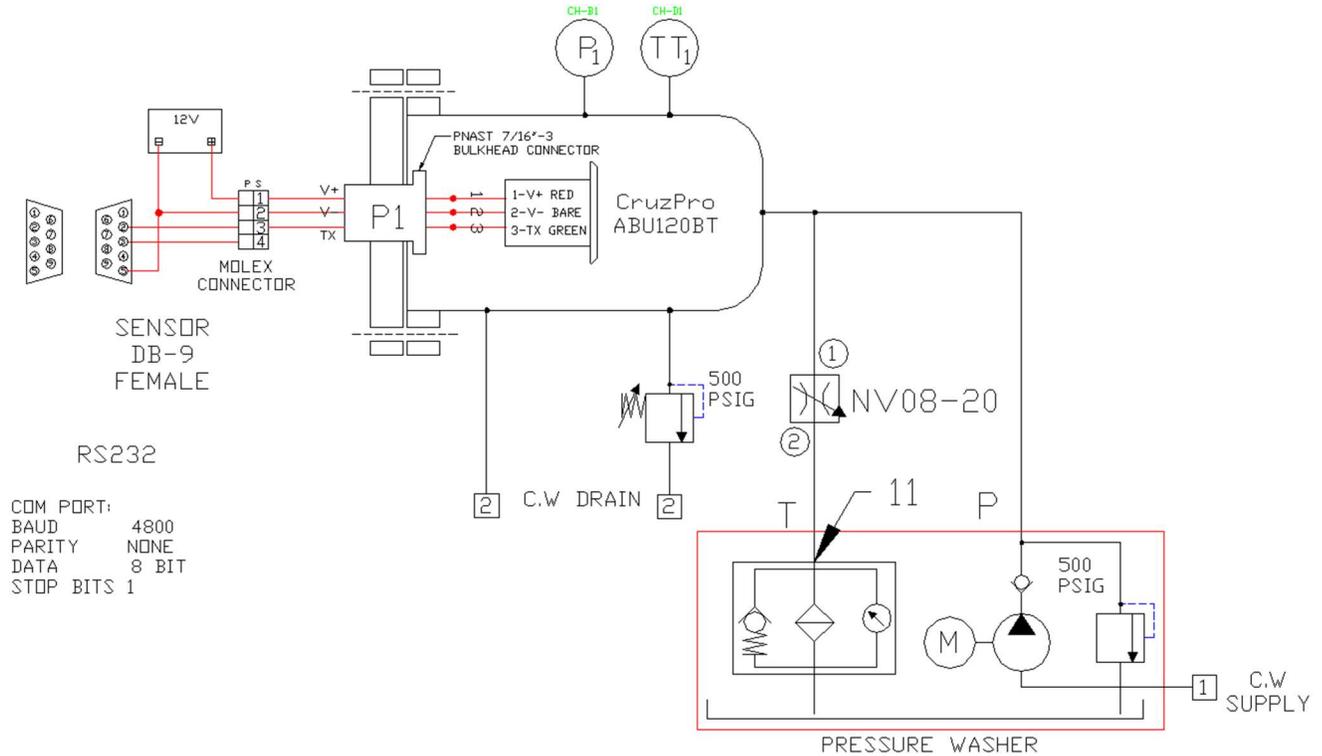
Figure 4 - Setups for Pressure Test

was used. By closing off more and more of the bypass flowrate, the pressure in the chamber is increased. For the 1,000 fsw test (444 psig), the external pressure relief valve was set to 500 psig.

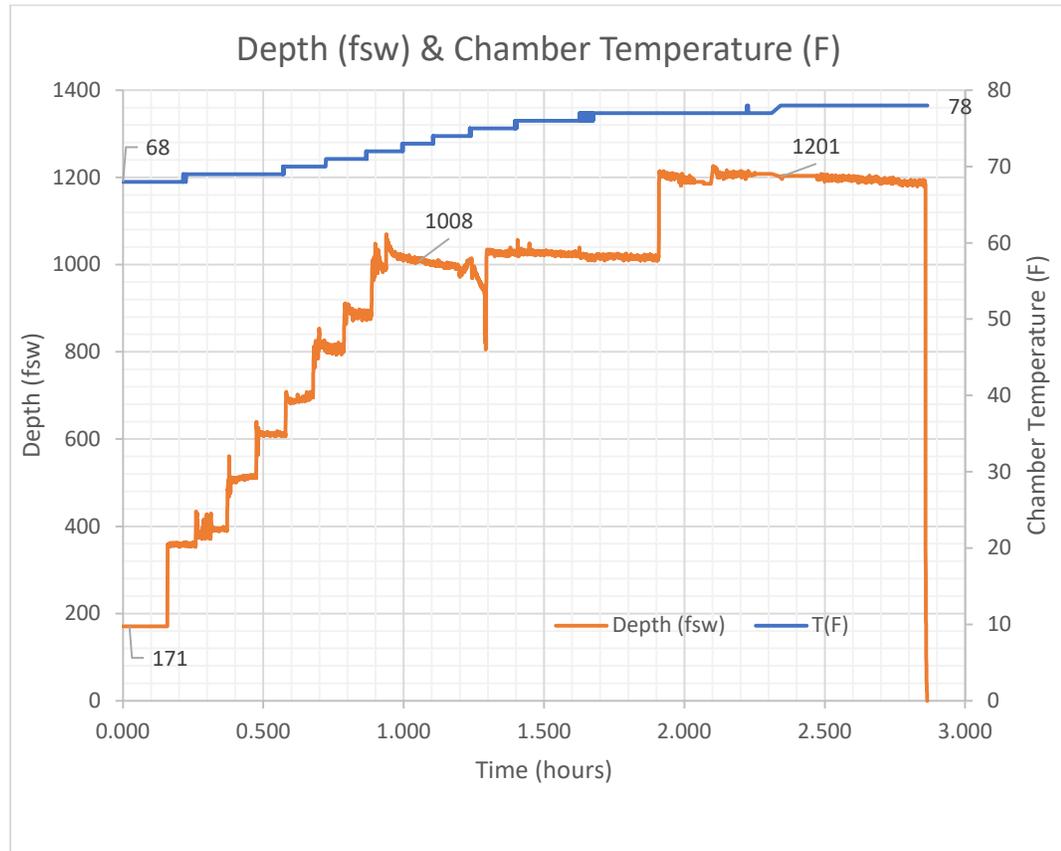
Figure 5 - Plot of depth (fsw) and chamber temperature

The test was done on April 30th at starting at 10:37 am. Figure 5 shows the depth and temperature over the test period.

The pressures and temperatures shown in Figures 5 and 6 are from test chamber instrumentation not from the ABU120BT.

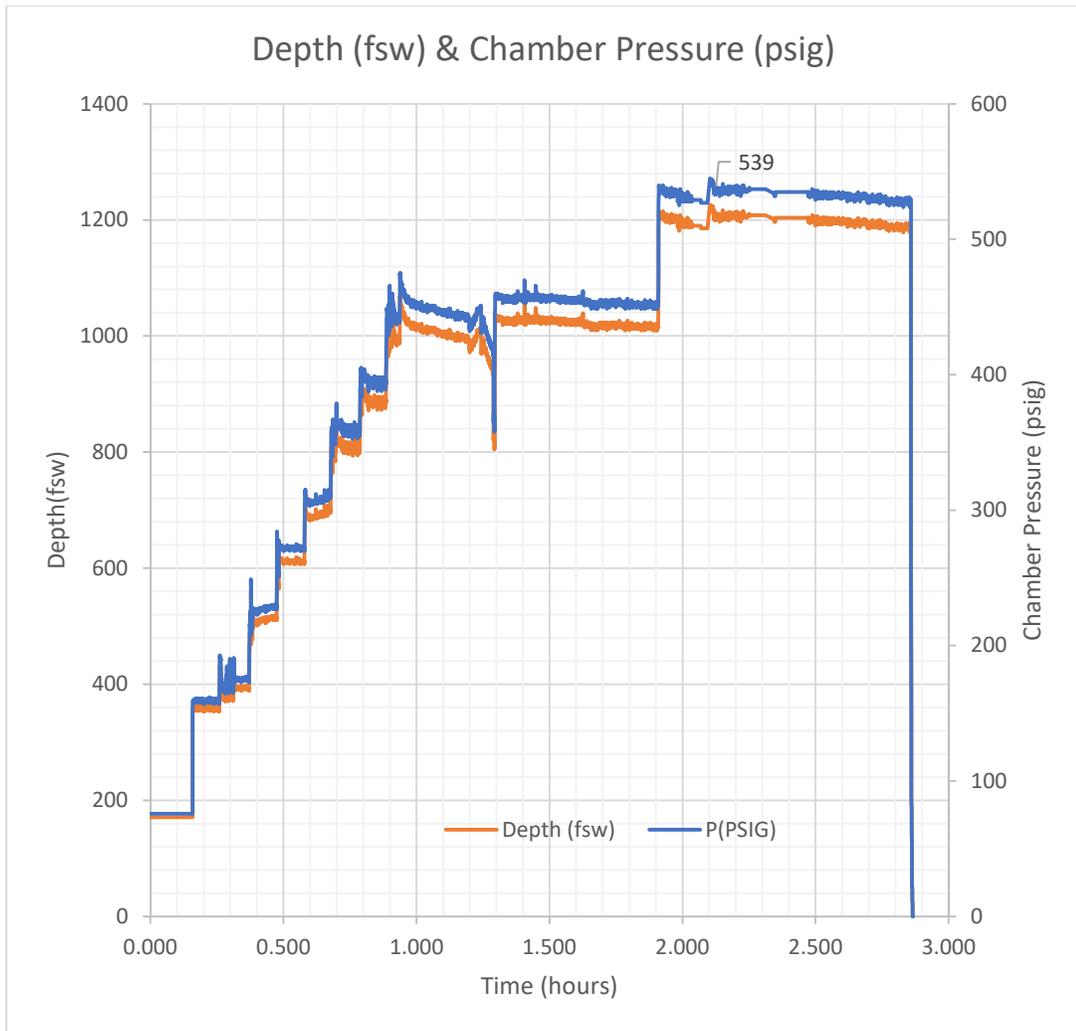
Figure 6 - Plot of depth (fsw) and chamber pressure (psig)

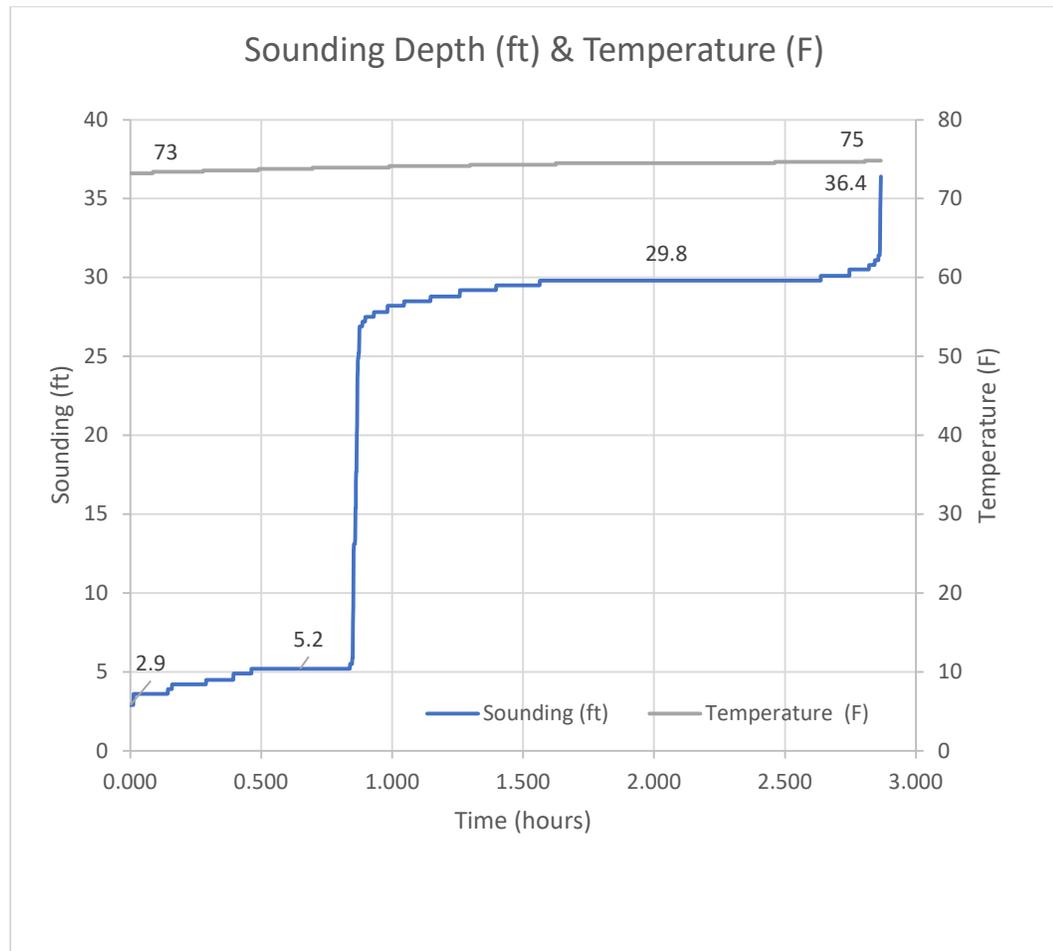
Figure 7 - Plot of sounding (fsw) and temperature (F)

Figure 7 plots the ABU120BT transmitted data converted to imperial units. As shown from the data, the unit continued to output data though out the test. As the transponder was in a steel test chamber with only a small distance from the transducer head to the chamber wall, any sounder data is meaningless. If you compare the temperature from the ABU120BT to that of the RTD on the test chamber, you see some discrepancy.

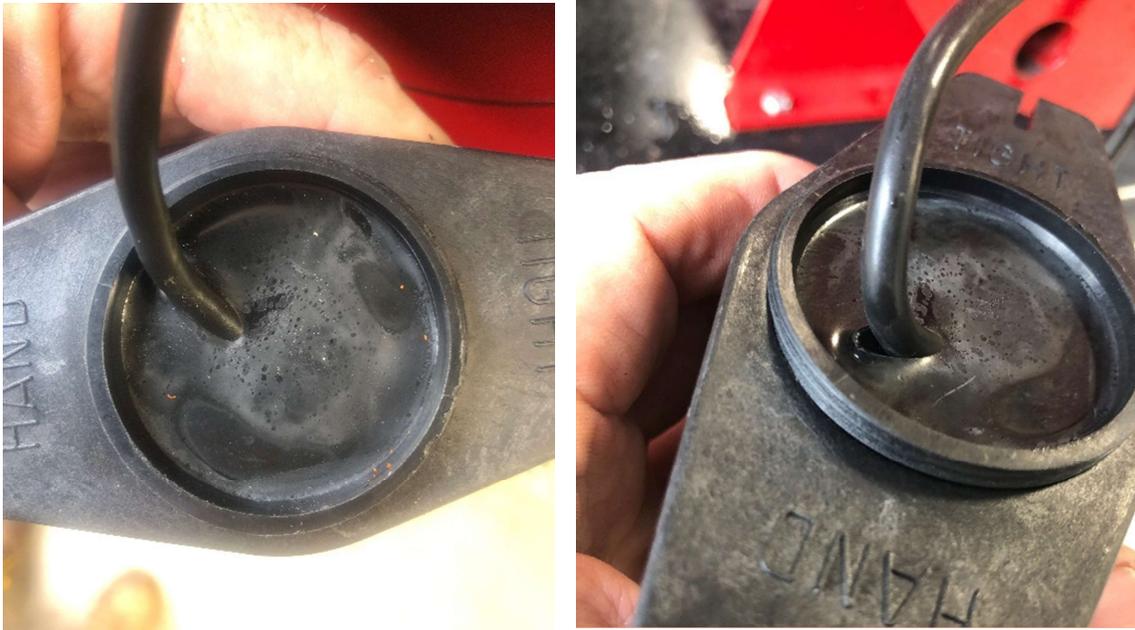
Figure 9 shows the before and after images of the ATU120BT. After inspection a separation was observed between the epoxy potting and the transducer cable where it enters the unit. It is probable that the pressure caused the soft insulation around the cable to compress away from the epoxy potting material. No other cracks or separation was observed and this separation did not lead to the unit failing. Preventing this possible water egress location is an area that for future development particularly if deeper utilization of the device is expected.

Figure 9 - Before and after images of ATU120BT

One possible solution for the separation issue around the cable would be to use RTV108 silicone sealant around the area the cable protrudes from the back of the sounder after roughing up the cable jacket as well as the top of the ATU120BT with a fine grit sand paper. IPA would be used to clean the cable and the top of the sounder prior to applying the sealant. This fix could be tested in the vertical test chamber described above.

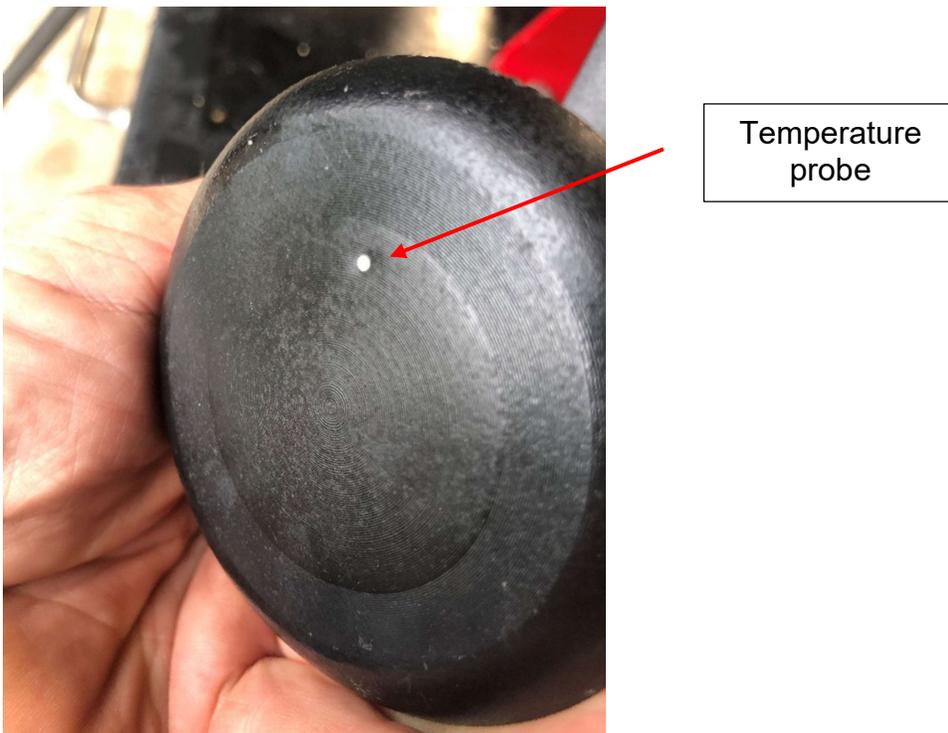
Figure 10 - After image of ATU120BT face

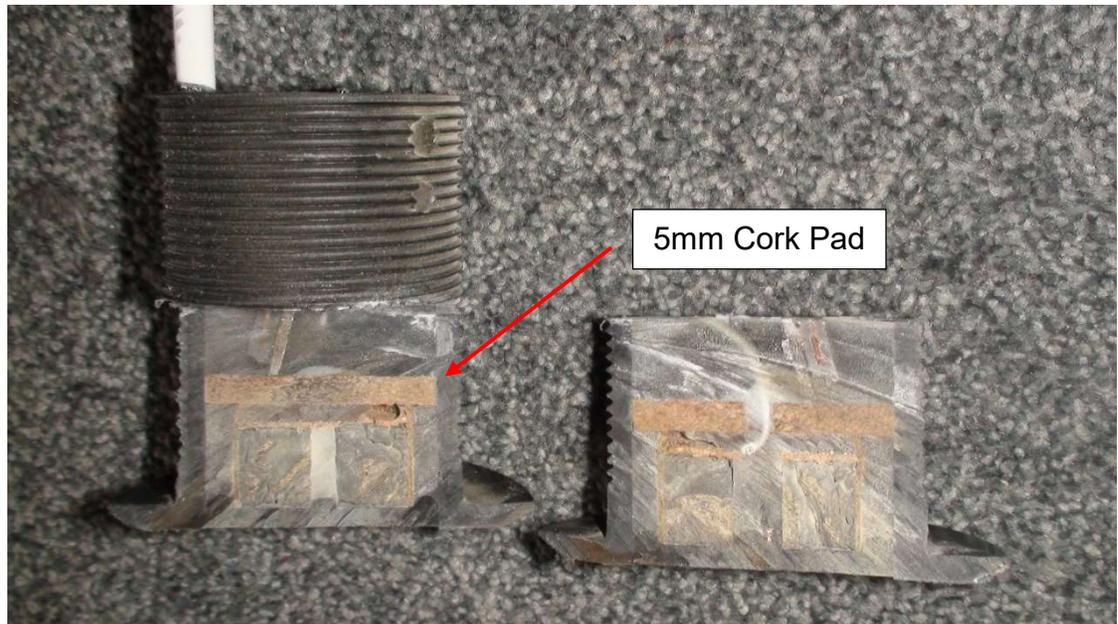
See Figure 11 for picture of an ATU120BT that has been cut along the long axis of transponder with a table saw. Note the orange areas in the figure are cork.

Figure 11 - Cross sections of CruzPro ATU120BT

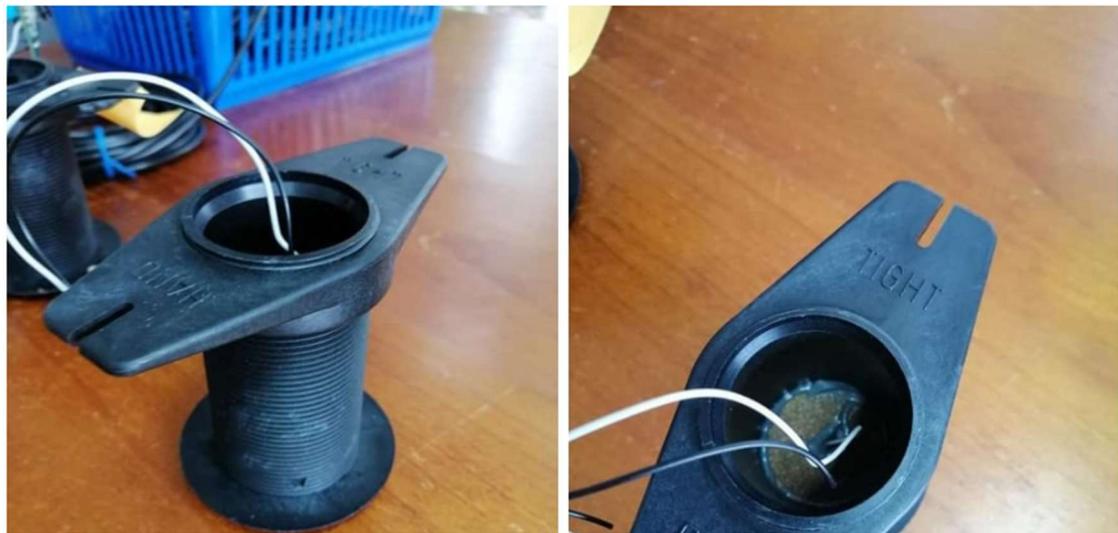
Figure 12 - ATU120BT depth sounder. Before potting electronics

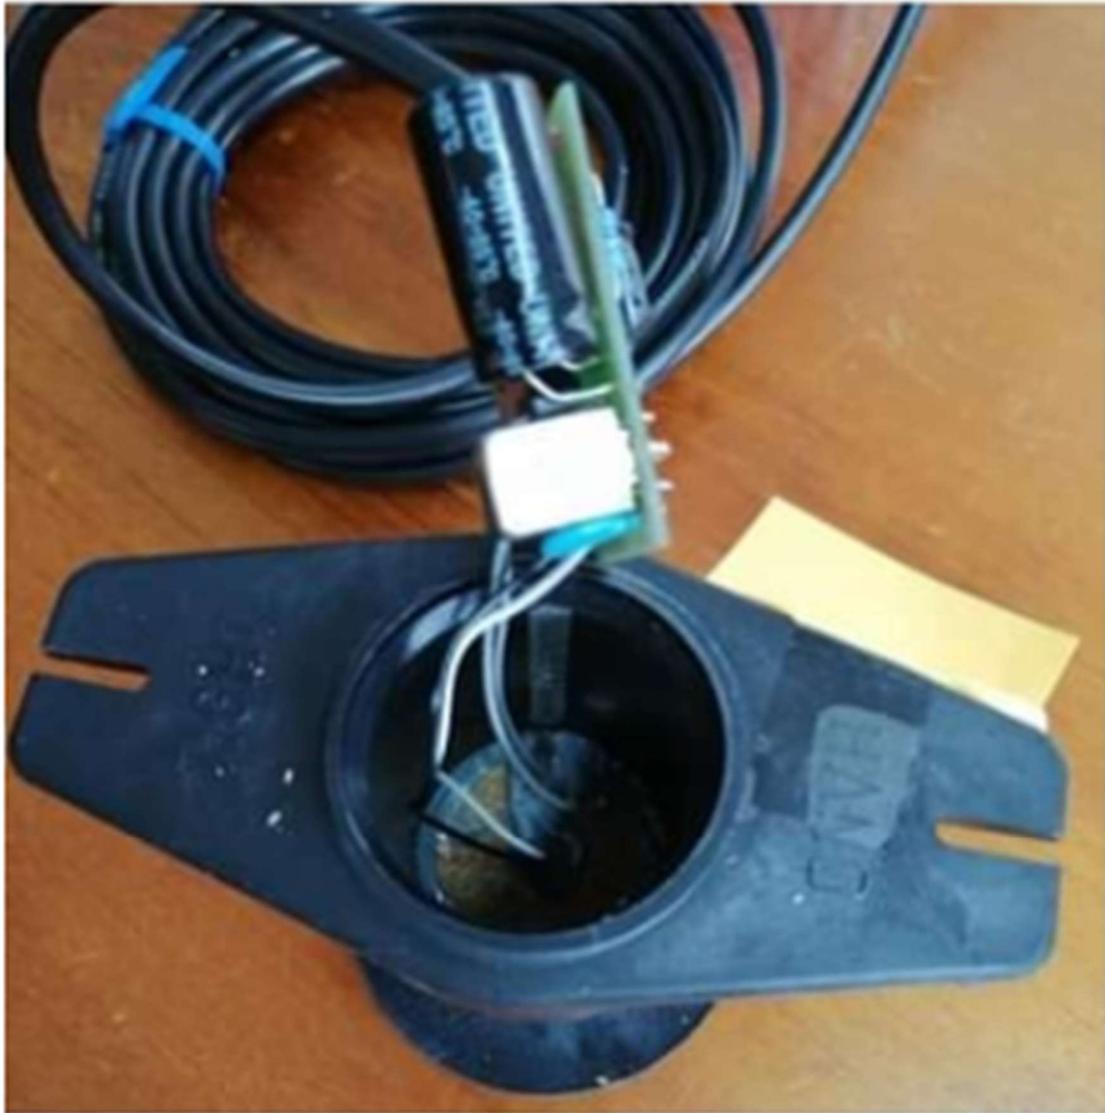
Figure 13 - ATU120BT depth sounder. PCB Before potting

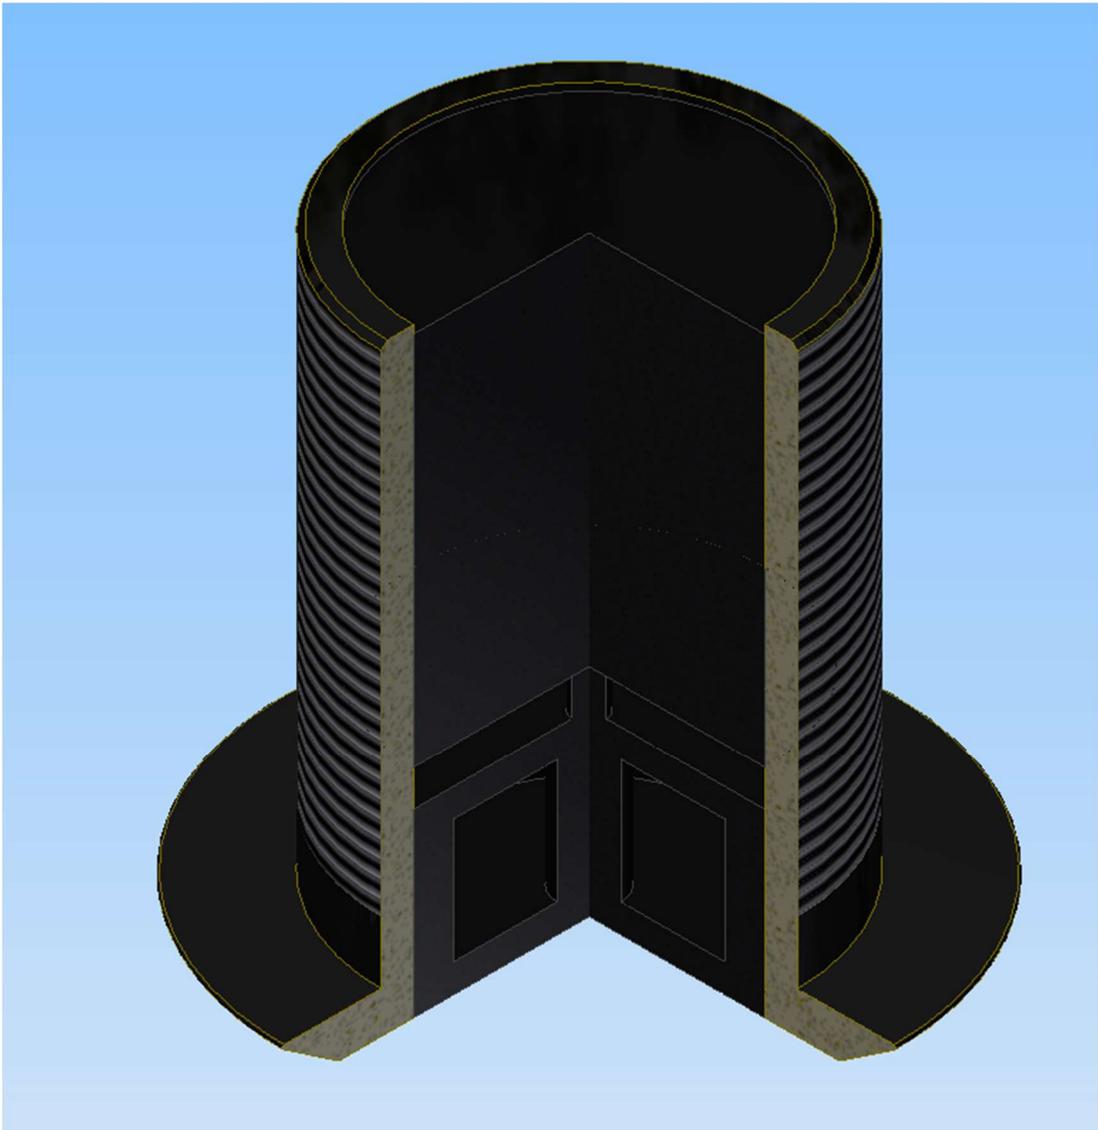
A $\frac{3}{4}$ section view of the model is shown in Figure 14. The geometry used in the analysis is given in Figure 14. As a worst-case scenario, the analysis was done with the assumption that the cork parts and the piezoelectric element were removed. These would be parts 4, 5 and 6 in Figure 15. Cork is roughly 15% solid and the rest is air. Its density is typically about 15% that of water. Structurally it does not provide significant support.

Figure 14 - 3/4 section view of the assembly (electronics omitted)

The loading case was 889 psig distributed on the exterior of the transponder. The model was fixed at the inside face of the 3" mounting flange.

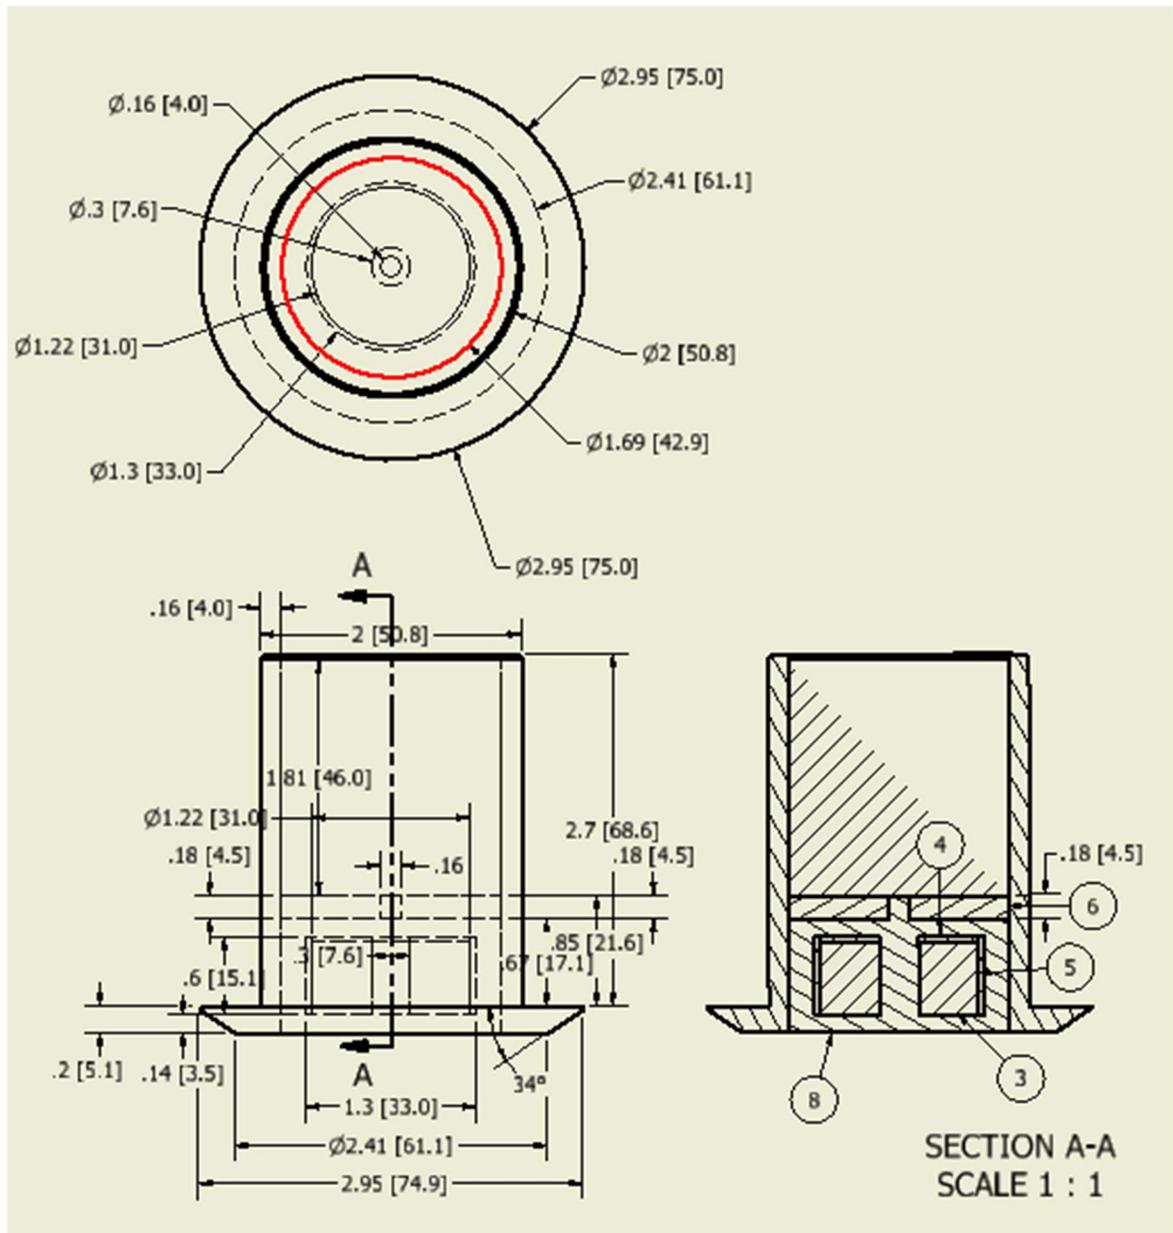
PARTS LIST			
ITEM	QTY	PART NUMBER	DESCRIPTION
1	1	ABT120BT-01	Radarsonics 408 Plastic Housing
3	1	ABT120BT-03	Piezoelectric element
4	1	ABT120BT-04	CruzPRo120BT-Cork on top of element
5	1	ABT120BT-05	CruzPro ABT120BT - Cork shell around element
6	1	ABT120BT-06	CruzPro ATU120BT - Thick cork pad 5mm pad
8	1	ABT120BT-02A	West systems 105 Epoxy Resin, below the 5mm cork
9	1	ABT120BT-02B	West systems 105 Epoxy Resin, above the 5mm cork

Figure 15 - Geometry of CruzPro ATU120BT use for FEA analysis

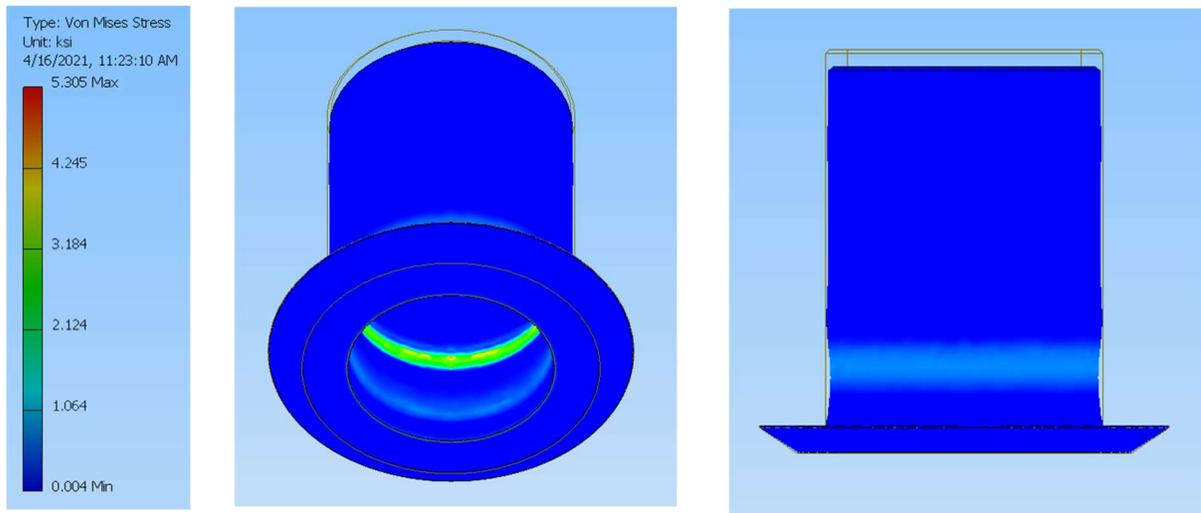
Figure 16 - Von Mises stress of the Radarsonic 408 housing

The primary effect on the housing was the bulging out (radial displacement) of the wall in an accordion fashion due to compression of space occupied by the 5 mm cork pad.

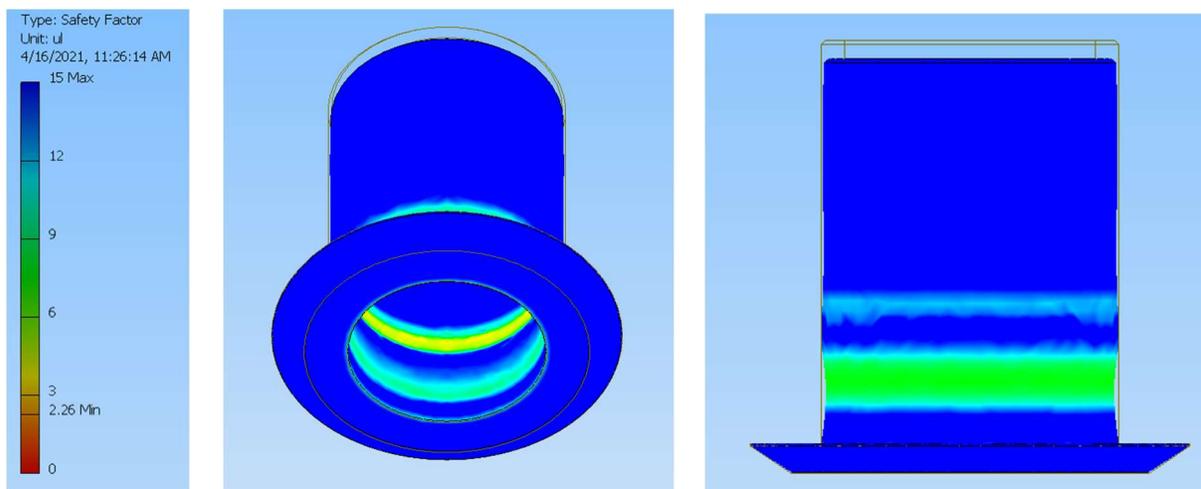
Figure 17 - FS for the Radarsonics 408 housing

For Nylon 6/6, the yield stress is 12,000 psi giving a minimum factor of safety (FS) of 2.26. Note that all the figures showing deflection are exaggerated to better show displacement.

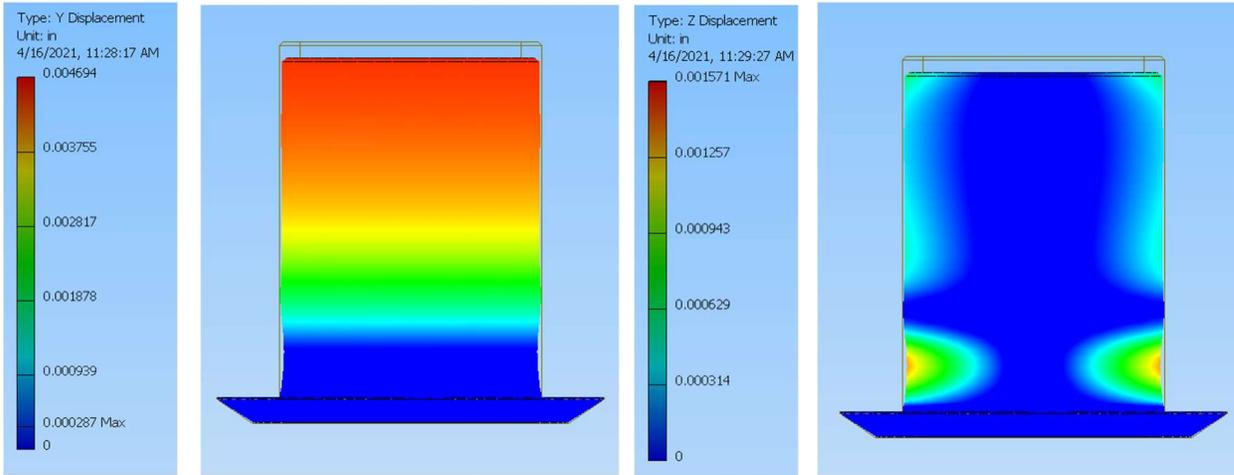
Figure 18 –Displacement Radarsonics 408 housing

- 3) Due to the hydrostatic pressure and the lack of structural support of the housing wall at the location of the 5mm pad, the housing displaces radially outward at the location of the 5 mm pad but not as much as when the 4 mm column was not in place.

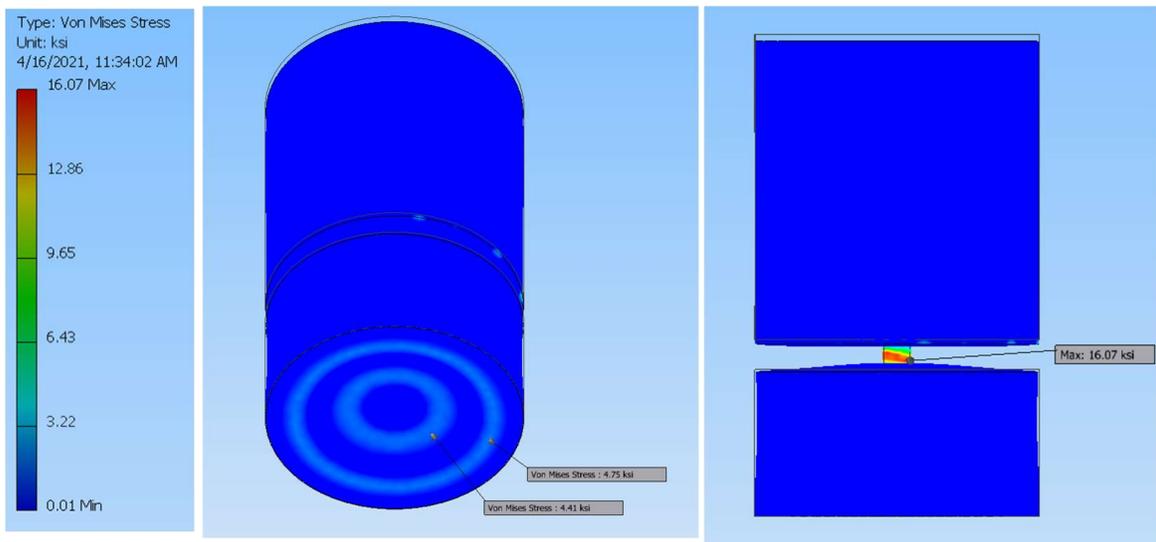
Removing the 408 housing and showing just the epoxy resin above and below the 5mm pad enables us to look at the effect of the 889 psig hydrostatic pressure on this part of the transponder. Figure 19 shows the Von Mises stresses in the epoxy.

Figure 19 - Von Mises stresses in the epoxy around the 5mm cork pad

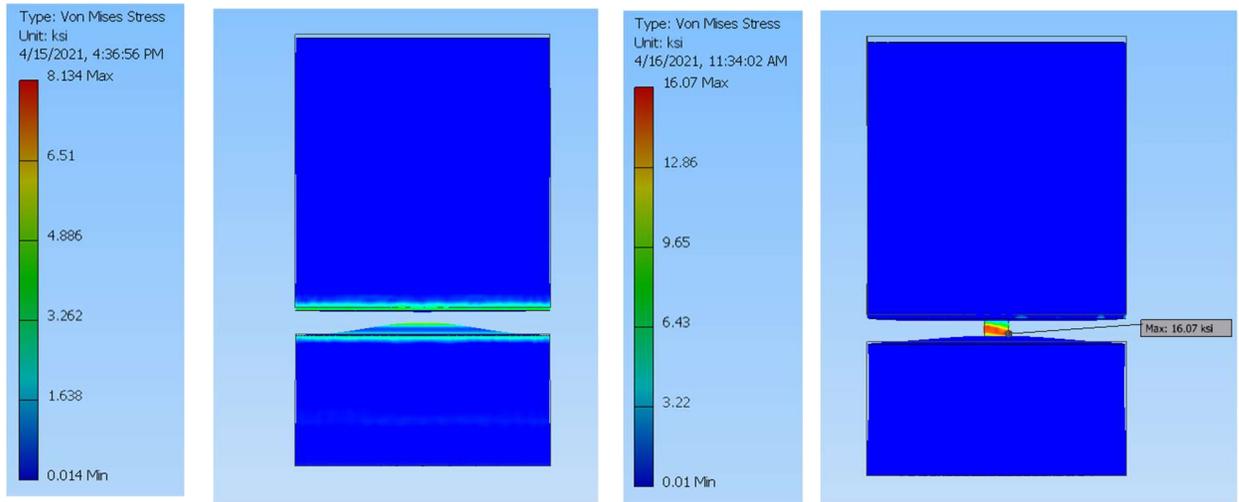
With the addition of the 4 mm diameter column through the 5 mm thick cork section, the displacement of the seaside face has been reduced by 42% but the column is under considerable stress to point that it has exceeded the yield stress. The maximum Von Mises stress in this column is 16.07 ksi. The seaside face of the transponder von Mises stress decreased from 8.134 ksi to 4.75 ksi due to the column. Figure 21 shows a close up of the stress in the 4 mm diameter column. Factor of safety (FS) are shown in Figure 22. Note that the lowest FS for the assembly is the 4 mm diameter column in the 5 mm thick cork pad. Figure 23 shows the displacement in the Y-axis (log axis of transponder). The maximum displacement of the sea side face of the transponder is 0.0103 in (26mm).

Figure 20 - With and without epoxy column of Von Mises stresses

- 2) With the addition of the 4 mm column, the maximum Von Mises stress goes above the yield stress of the epoxy. The location of the maximum stress is the 4 mm column with the stress being in compression. Exceeding the yield stress at this point indicates this column will plastically deform to some extent to relieve the stress on the first excursion to 2,000 fsw. In other words, it will not spring back to the original thickness as it would if the stress had been below the yield stress of the epoxy. The column is still reducing the deflection of the seaside face. As such, as long as the epoxy does not separate from the body of the housing, the transducer should be OK even with a slight deformation of the 4 mm cutout.

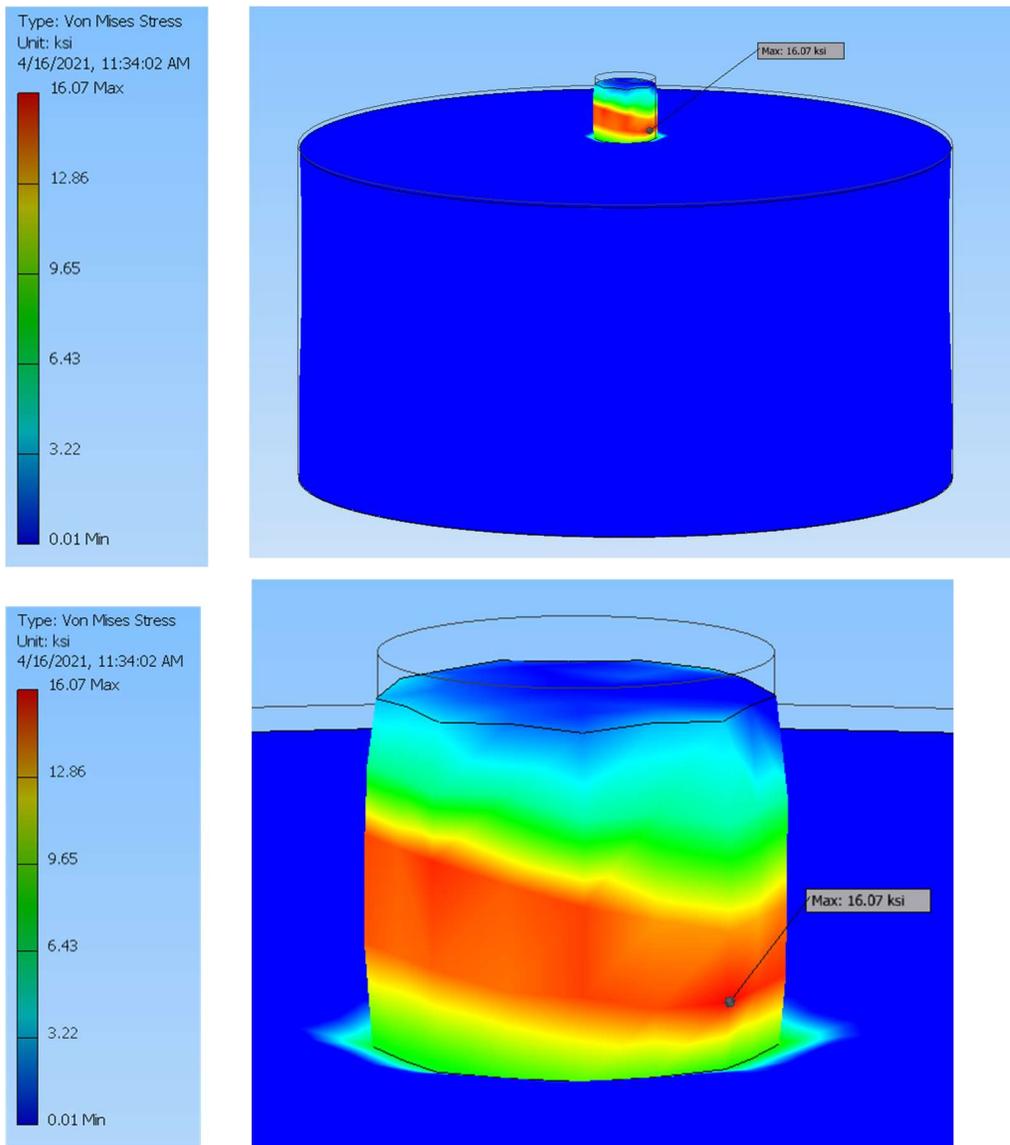
Figure 21 - Von Mises stresses in the epoxy in the 5mm cork pad hole

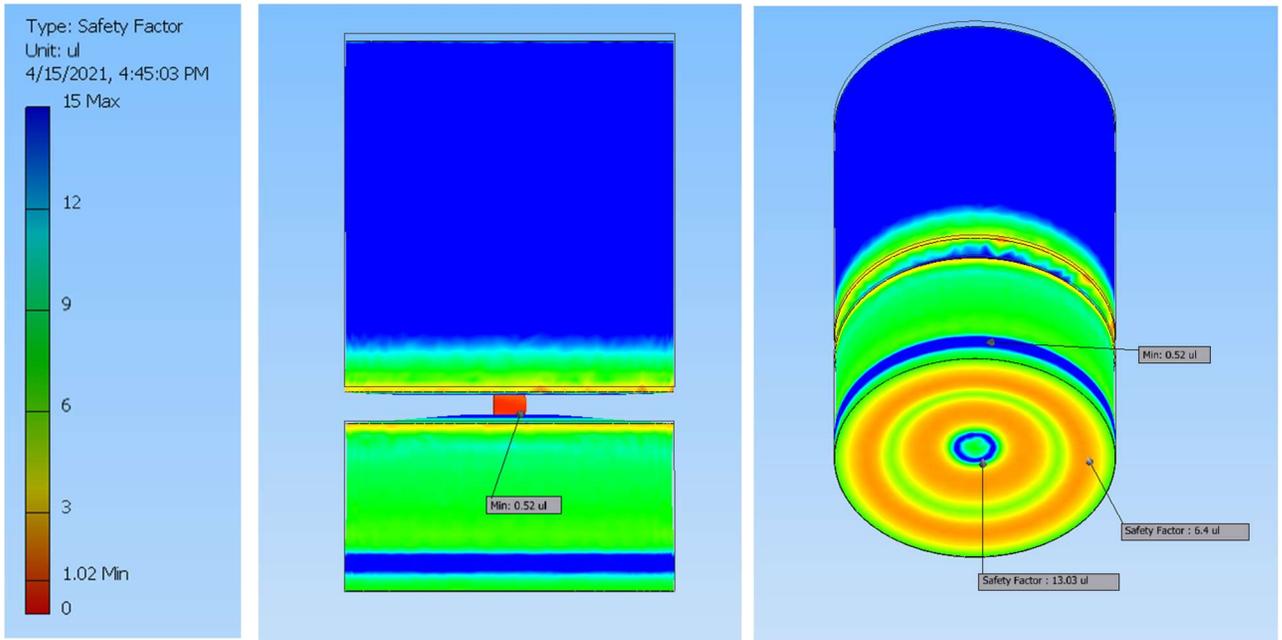
Figure 22 - FS in the epoxy above and below the 5mm cork pad

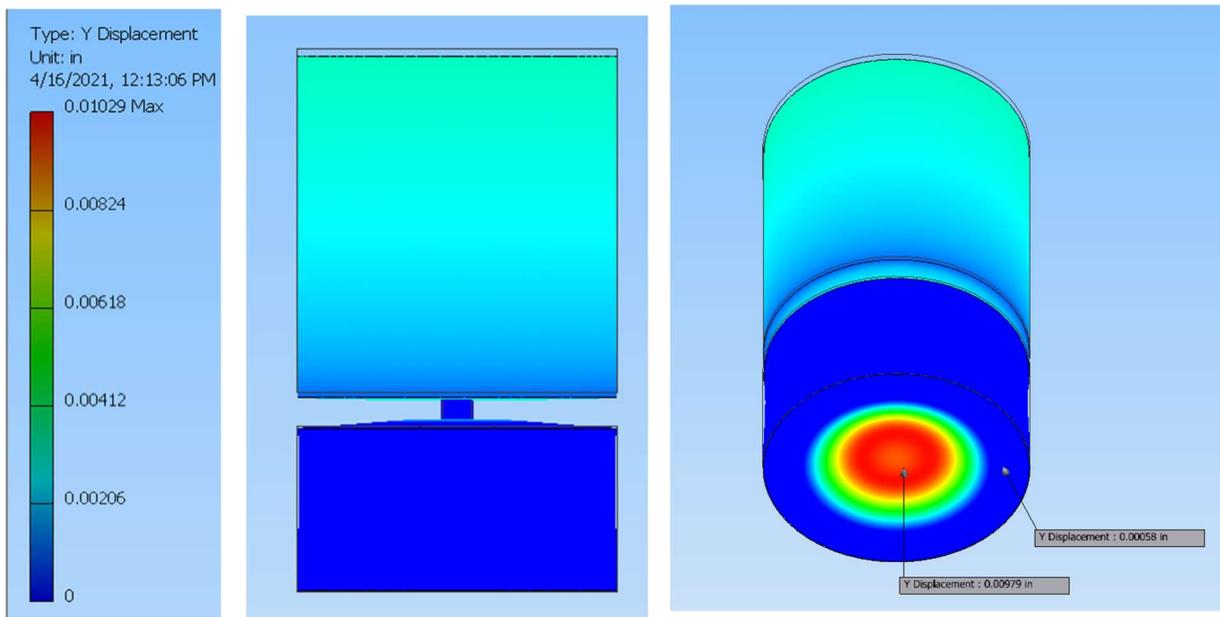
Figure 23 - Displacement in the epoxy above and below the 5mm cork pad

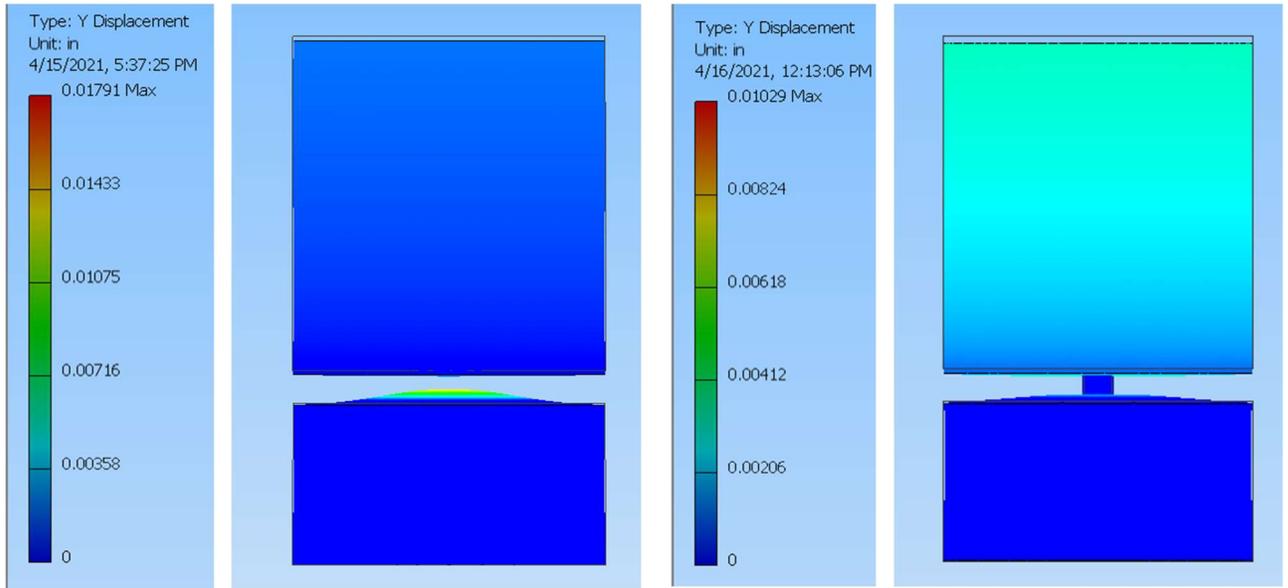
Comparing with and without the 4 mm diameter epoxy column, as seen in Figure 24, with the column, the maximum displacement of the seaside face is reduced from 0.0179 in (0.45mm) to 0.0103 in (26mm).

Figure 24 - Comparing displacement with and without the 4 mm epoxy column

- 1) The inclusion of the 4 mm diameter cutout in the 5 mm cork pad reduces the maximum displacement of the sea side face by 42% dropping it from 0.0179 in (0.45m) to 0.0103 in (0.26mm). This epoxy filled cutout is acting as a column transferring the load from the seaside face of the transponder to the upper epoxy section.
