Project Title - Evaluation of CruzPro ATU120BT

File Ref.
TR-21-03

Evaluation of CruzPro ATU120BT Active Sonar Transducer for Manned Submersibles

May 5, 2021

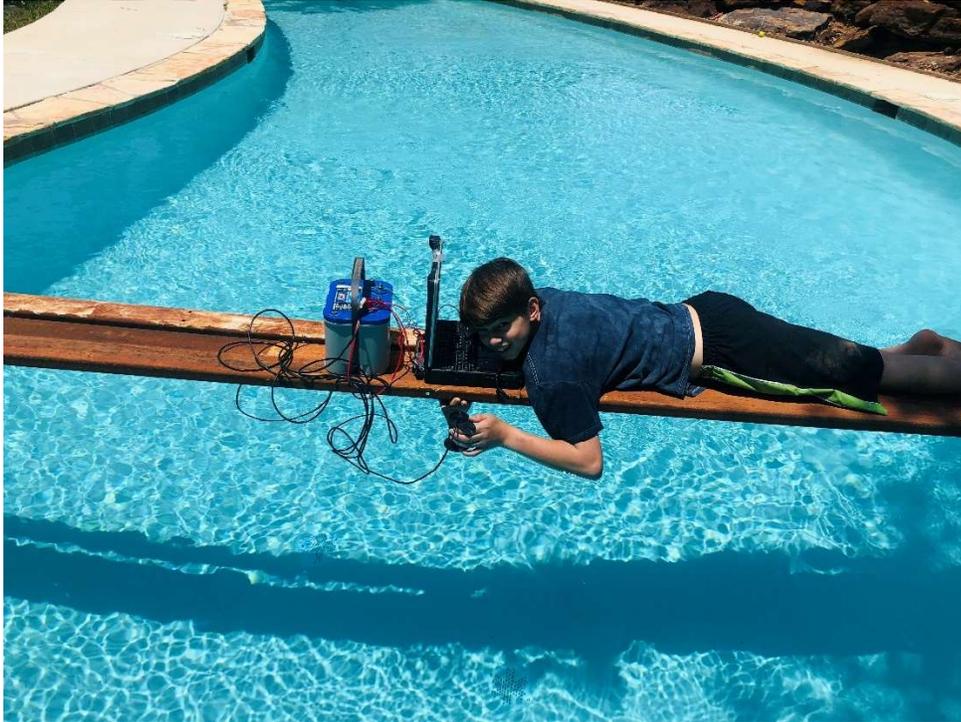
On 5/4/21, a pool test was conducted in which the sounder was suspended over the deep end of a swimming pool as shown in Figure 25.

Figure 25 - Setup for Pool Test

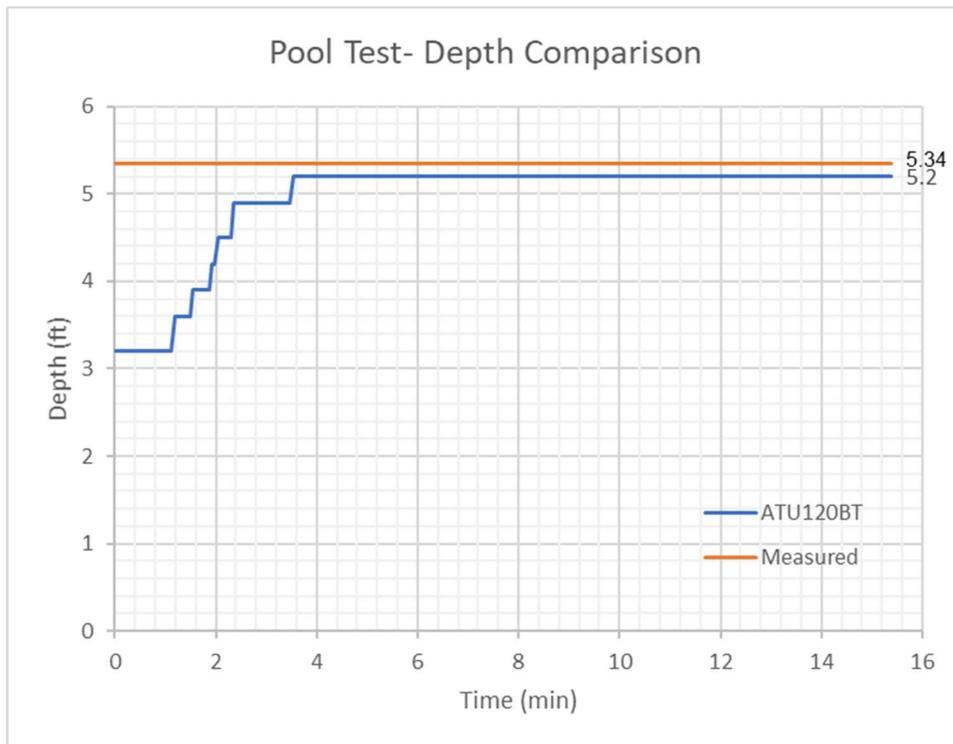
Figure 26 - Pool Test - Depth Comparison

Depth sounding from the ATU120BT are plotted against a tape measured depth in Figure 26 and also presented in Table 5. The first three minutes after the data logging began was getting in position in which the sounder was not in final position.

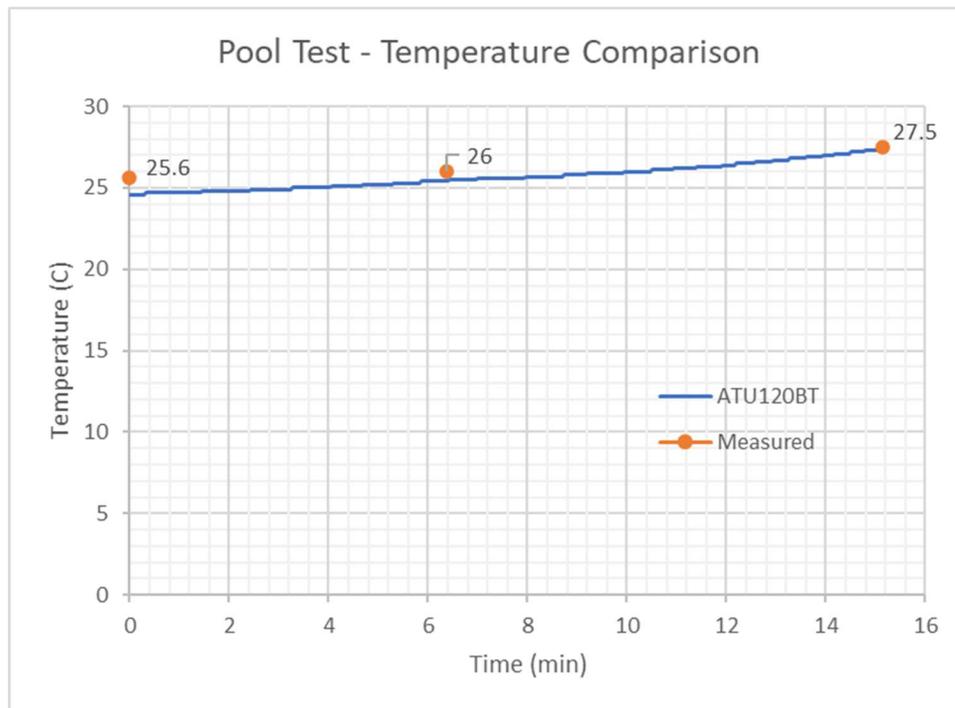
Likewise, the temperature comparison is shown in Figure 27. The measured values were from an inexpensive floating pool thermometer.

Figure 27- Pool Test - Temperature Comparison

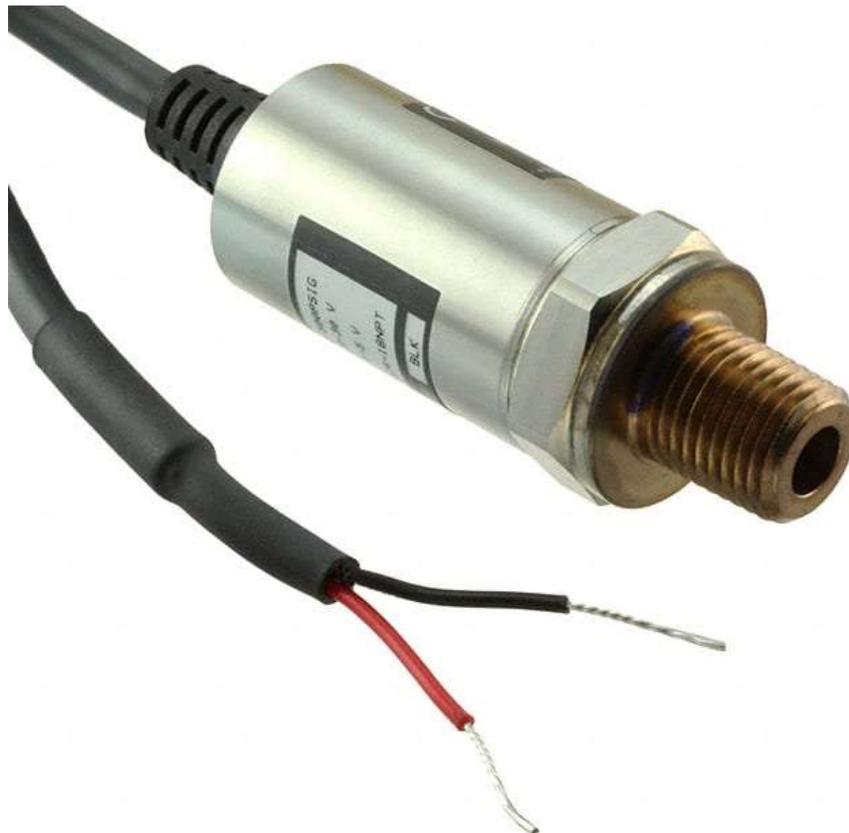
Item	Description
Application	High Pressure Transmitter
Manufacturer	TE Connectivity Measurement Specialties
Mfg. Model No.	M5231-000005-03KPG
Digi-Key Part Number	223-1726-ND
Description	TRANSDUCER 0.5-4.5VDC 3000PSI
Pressure Type	Vented Gauge
Operating Pressure	3000 PSI (20684.27kPa)
Type	Analog Voltage
Output	0.5 V ~ 4.5 V
Accuracy	±0.25%
Voltage - Supply	4.75V ~ 5.25V
Port Size	Male - 1/4" (6.35mm) NPT
Features	Temperature Compensated
Termination Style	Cable
Maximum Pressure	6000PSI (41368.54kPa)
Operating Temperature	-40°C ~ 125°C
Package / Case	Cylinder
Datasheet	M5200 Industrial Pressure Transducer (te.com)

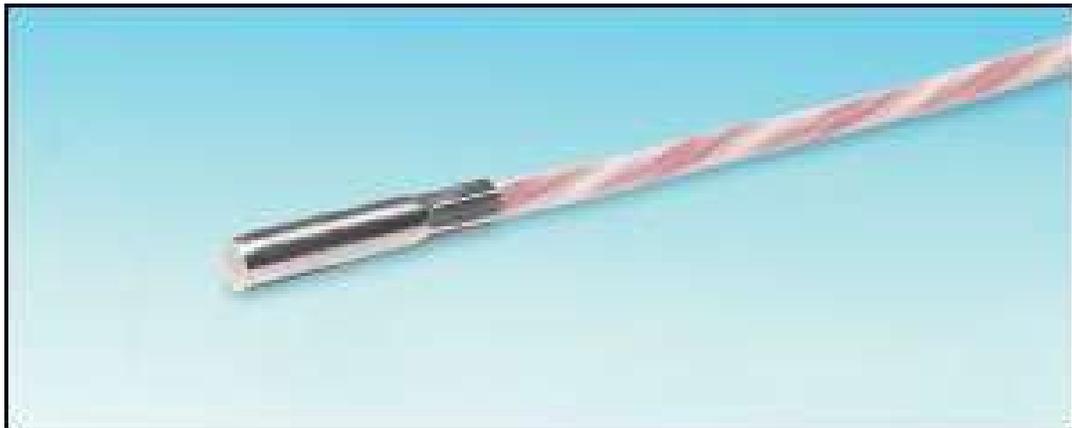
Item	Description
Application	Test Chamber Temperature RTD
Manufacturer	DC Direct
Mfg. Model No.	314-140 Small Budget RTD Sensor
Description	100 ohm RTD element, Alpha = 0.00385, Class B
Temperature Range	-58°F to +390°F (-50°C to +200°C)
Probe Diameter	1/4"
Probe Length	1.18" long
Termination Style	3 wire configurations
Sheath	316 Stainless Steel
Extension Leads:	72" long, 24 AWG stranded PFA insulated cores with silicone rubber
Wire Color Code	3 wire - 2 colored red and 1 colored white
Datasheet	TC Direct for Temperature Sensing, Measurement and Control

the bottom of the chamber near the mid point. The RTD is just above this in a thread-o-let pipe fitting in the wall of the chamber. There was a small amount of water being emitted from the PRV so over the three hours test makeup water was added to replace this lost volume (3 quarts) by the pump. The pump was connected to the supply hose bibb by a long water hose. As the day went on the ambient temperature increased significantly (+20 °F) which in turned heated up the water hose. This hot water was being added slowly to the chamber and possibly heating up the water near the RTD. The ABU120BT located near the blind flange at the back of the cell was in stagnant water well away from this warmer water.

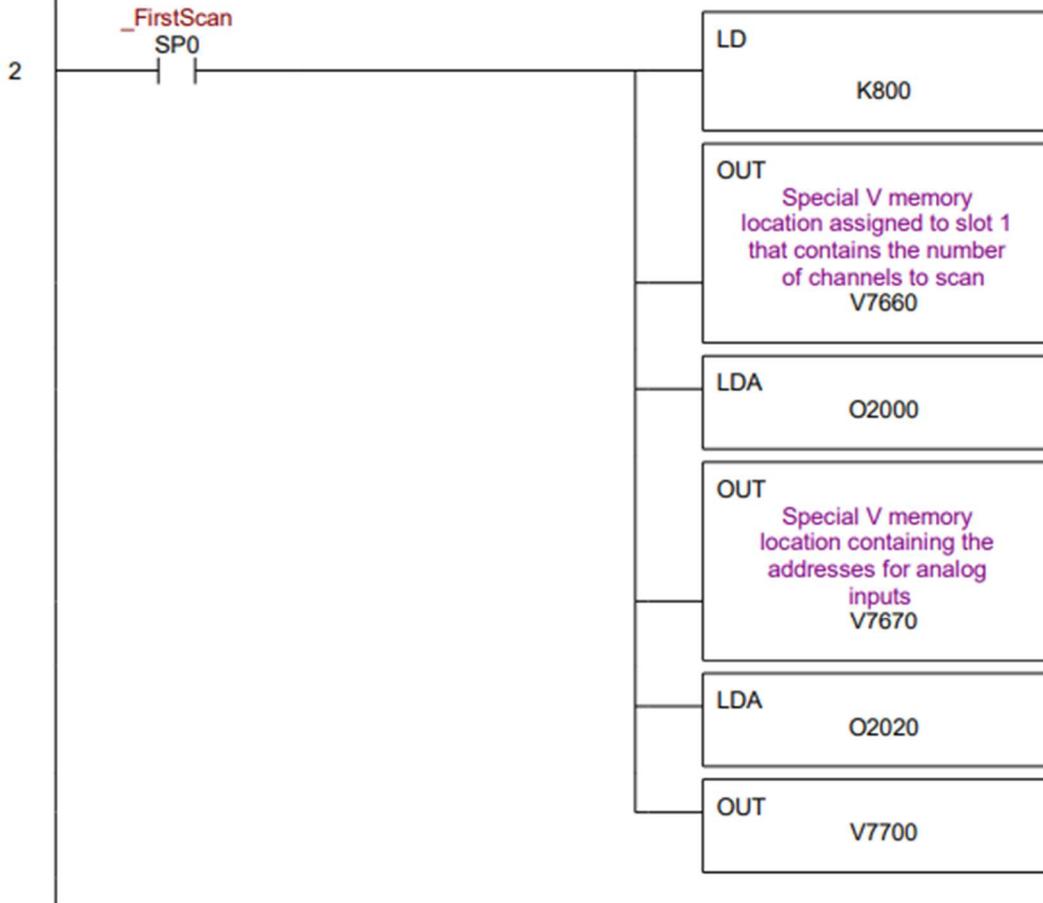
This rung specifies the number and location of V memory addresses into which the analog input signal from F2-08AD-2 module in slot 0, just to eft of CPU, will be stored. Channels are:

- CHB1 V2000 Chamber HP Pressure, psig (0-3000 psig)
- CHB2 V2001 Chamber LP Pressure, psig (0-5 psig)
- CHB3 V2002 Currently not used
- CHB4 V2003 Currently not used
- CHB5 V2004 Currently not used
- CHB6 V2005 Currently not used
- CHB7 V2006 Currently not used
- CHB8 V2007 Currently not used

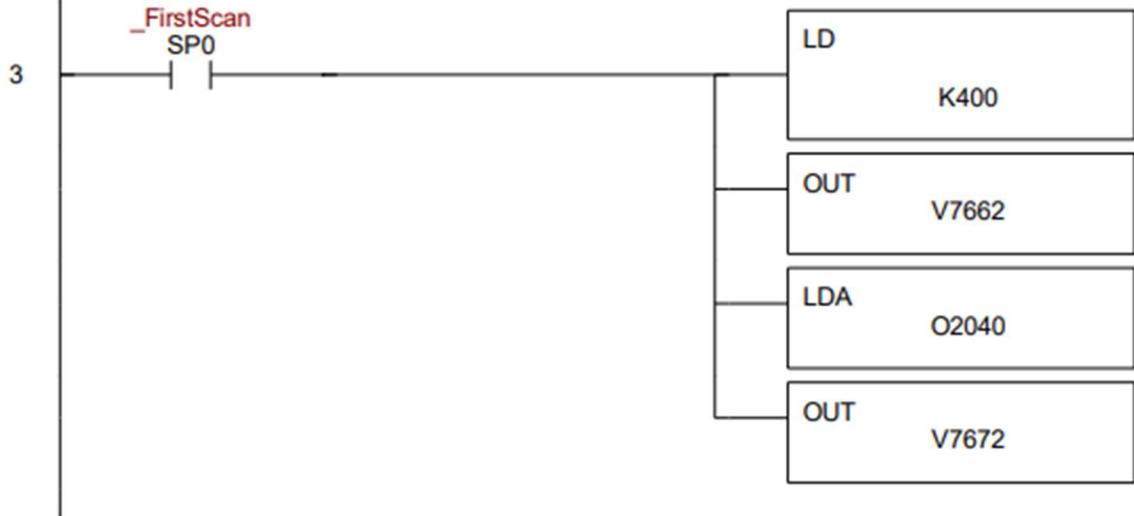
This rung specifies the number and location of V memory addresses into which the analog input signal from F2-04RTD module in slot 2 will be stored. Channels are:

- CHD1 V2040 Chamber Temperature, F *10
- CHD2 V2042 Currently Not Used
- CHD3 V2044 Currently Not Used
- CHD4 V2046 Currently Not Used

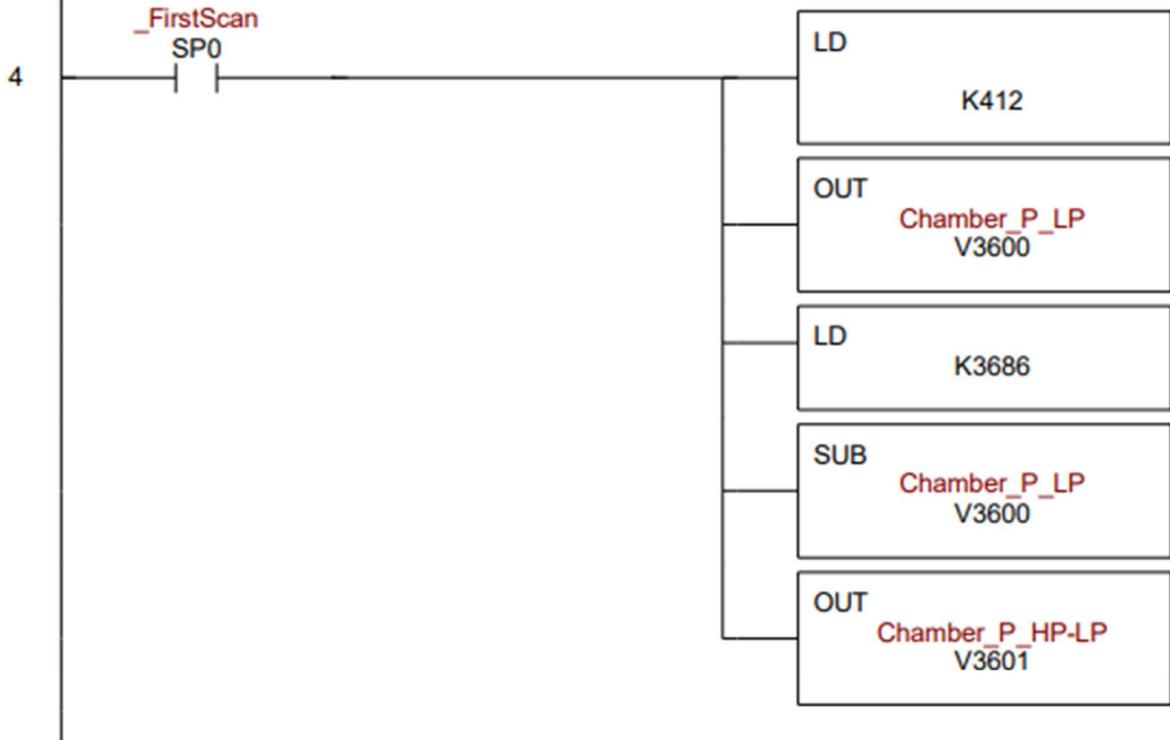
The rung sets up chamber HP pressure sensor processing. This sets the low pressure value and the difference in pressure between the LP and HP readings.

- V2000 = Chamber pressure signal (0-4095)
- V3600 = Pressure signal minimum value (0-4095)
- V3601 = Pressure signal maximum - Pressure signal minimum (0-4095)
- V3000 = Chamber pressure psig

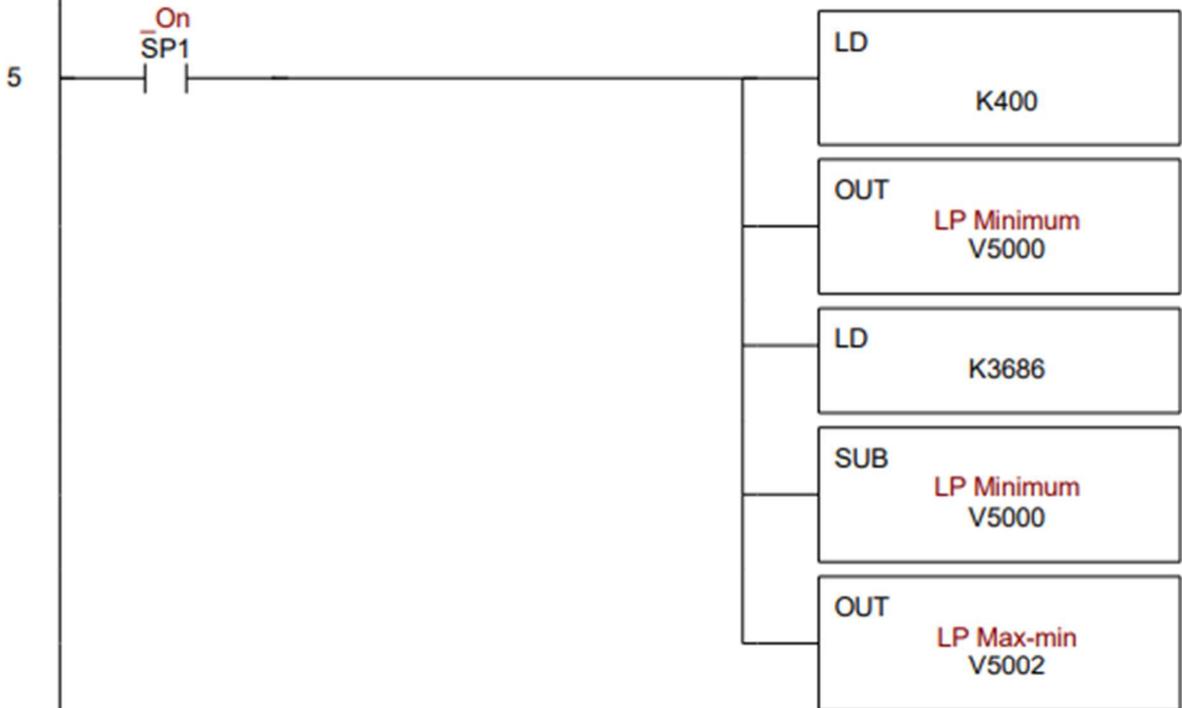
The rung sets up chamber LP pressure sensor processing. This sets the low pressure value and the difference in pressure between the LP and HP readings.

- V2001 = LP Chamber pressure signal (0-4095)
- V5000 = LP Pressure signal minimum value (0-4095)
- V5002 = LP Pressure signal maximum - Pressure signal minimum (0-4095)
- V5004 = LP Chamber pressure psig*100

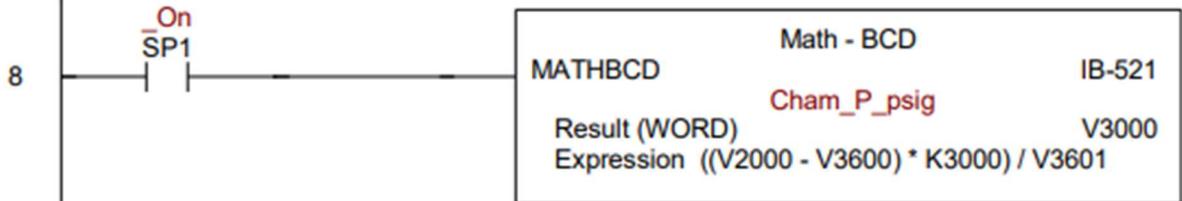
This rung converts the signal for chamber pressure, ranging from 0-4095, into psig. Sensor range is 0 to 3000 psig.

V2000 = Chamber pressure signal (0-4095)
 V3600 = Pressure signal minimum value (0-4095)
 V3601 = Pressure signal maximum - Pressure signal minimum (0-4095)
 V3000 = Chamber pressure psig

$$V3000 = (V2000 - V3600) * K3000 / V3601$$

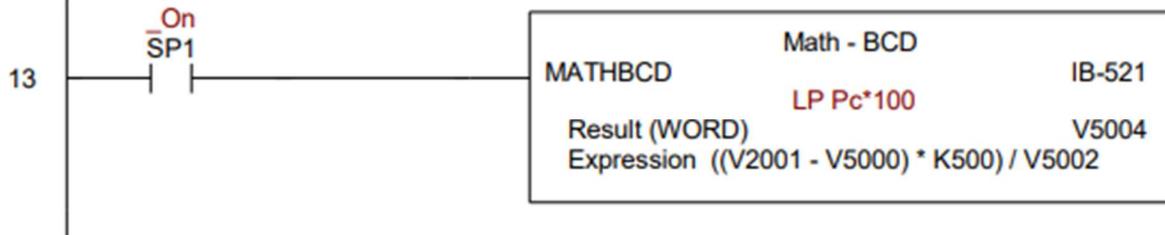
This rung converts the signal for LP chamber pressure sensor, ranging from 0-4095, into psig*100. Sensor range is 0 to 5 psig.

V2001 = LP Chamber pressure signal (0-4095)
V5000 = LP Pressure signal minimum value (0-4095)
V5002 = P Pressure signal maximum - Pressure signal minimum (0-4095)
V5004 = LP Chamber pressure psig*100

$$V5004 = (V2001 - V5000) * K500 / V5002$$

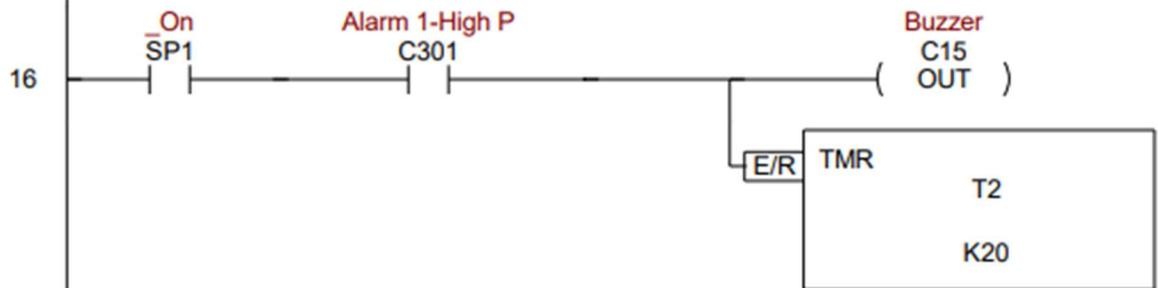
If alarms are enabled then if any individual alarm has been set, turn on buzzer for two seconds.

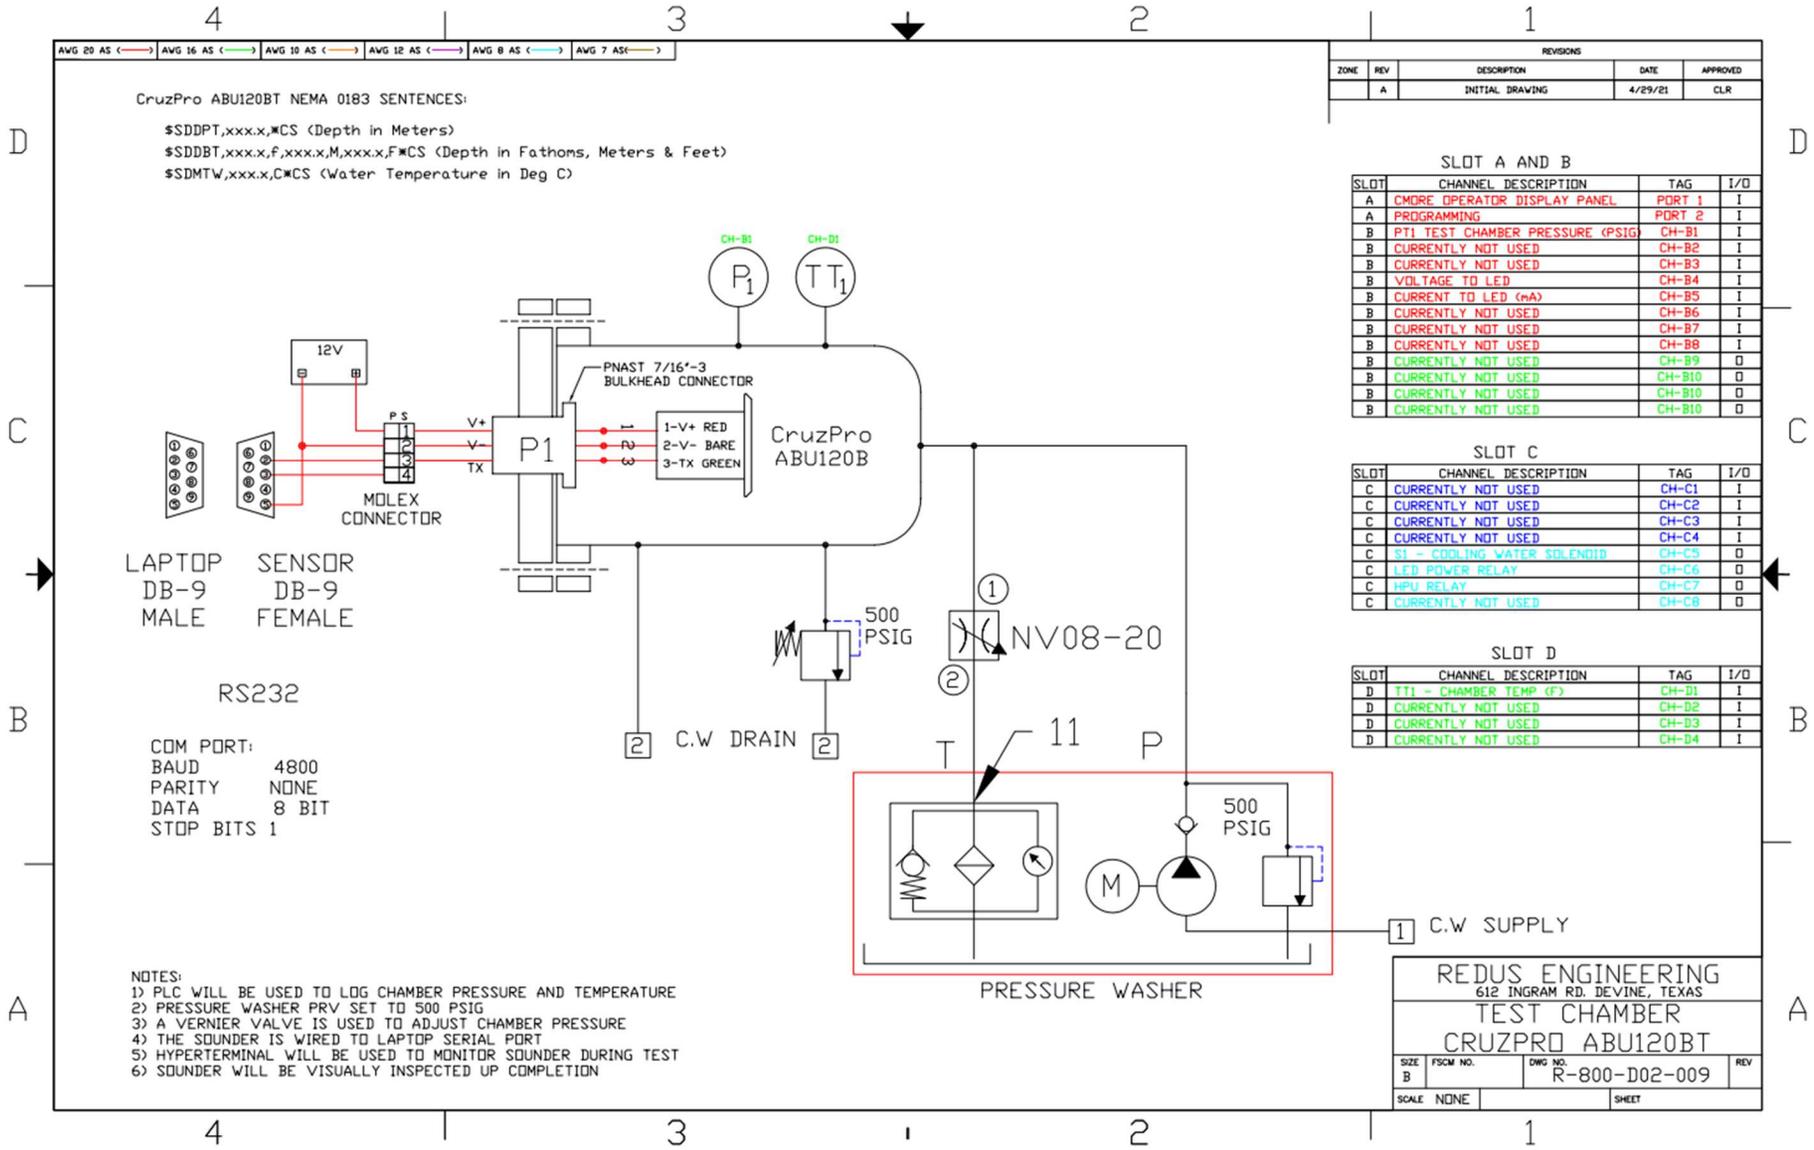
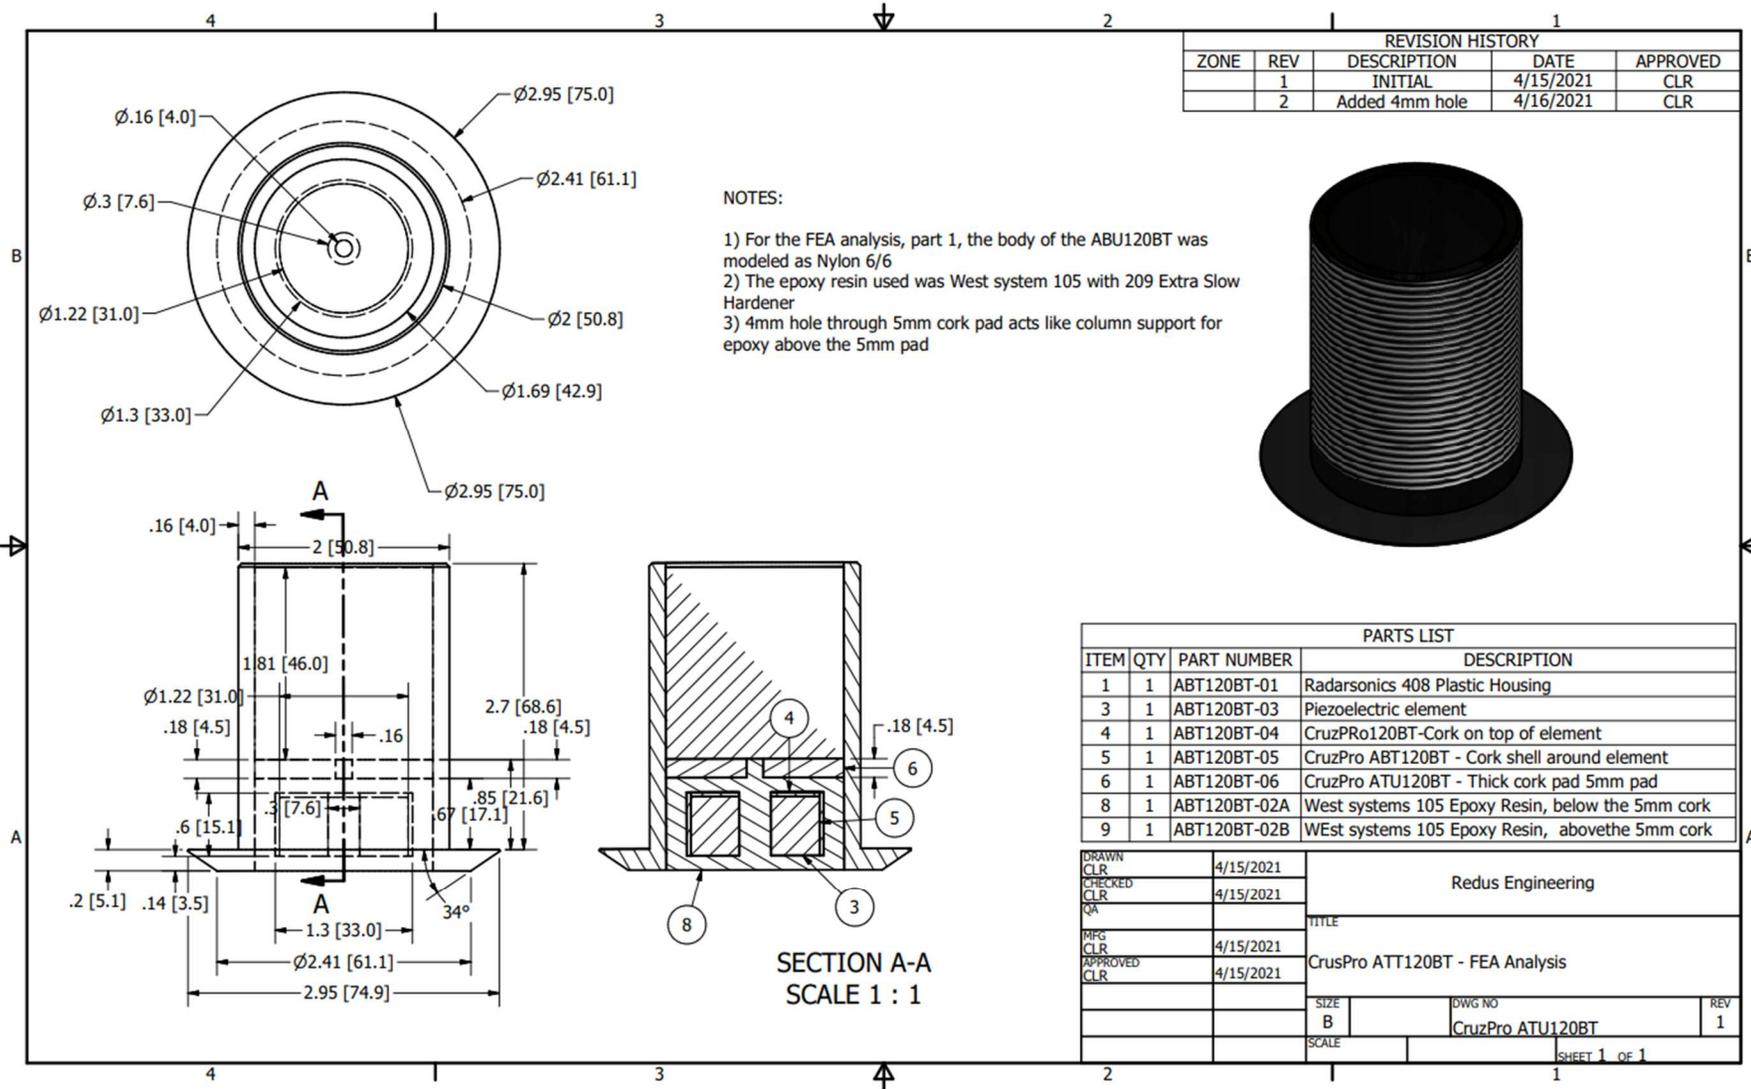
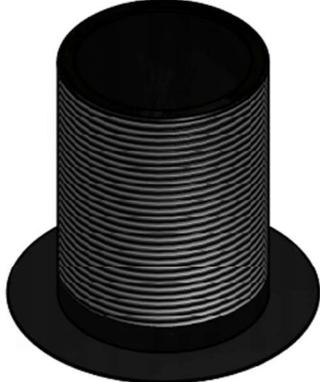
DRAWN CLR	4/15/2021	Redus Engineering	
CHECKED CLR	4/15/2021	TITLE	
QA		CruzPro ATT120BT - FEA Analysis	
MFG CLR	4/15/2021	SIZE B	DWG NO CruzPro ATU120BT
APPROVED CLR	4/15/2021	SCALE	REV 1
		SHEET 1 OF 1

- 1) For the FEA analysis, part 1, the body of the ABU120BT was modeled as Nylon 6/6
- 2) The epoxy resin used was West system 105 with 209 Extra Slow Hardener
- 3) 4mm hole through 5mm cork pad acts like column support for epoxy above the 5mm pad

PARTS LIST			
ITEM	QTY	PART NUMBER	DESCRIPTION
1	1	ABT120BT-01	Radarsonics 408 Plastic Housing
3	1	ABT120BT-03	Piezoelectric element
4	1	ABT120BT-04	CruzPro120BT-Cork on top of element
5	1	ABT120BT-05	CruzPro ABT120BT - Cork shell around element
6	1	ABT120BT-06	CruzPro ATU120BT - Thick cork pad 5mm pad
8	1	ABT120BT-02A	West systems 105 Epoxy Resin, below the 5mm cork
9	1	ABT120BT-02B	WEst systems 105 Epoxy Resin, abovethe 5mm cork
